CK-2417

STAVE RIVER 13.1km

2014 Inspection

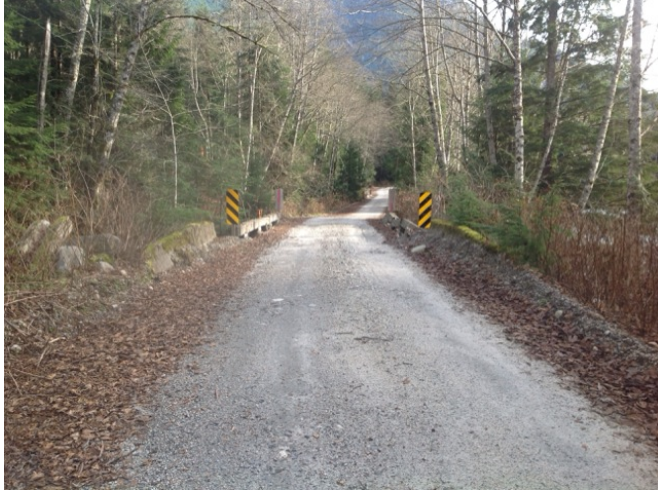
Approach from Right Bank when facing downstream

Bridge Ahead Signs  
Missing ☐ 0 ☐ 1 ☒ 2

Posted Load Rating not posted

| Repair Item | Priority | Repair Description |
|---|---|---|
| 3 | Medium | post bridge ahead signs |

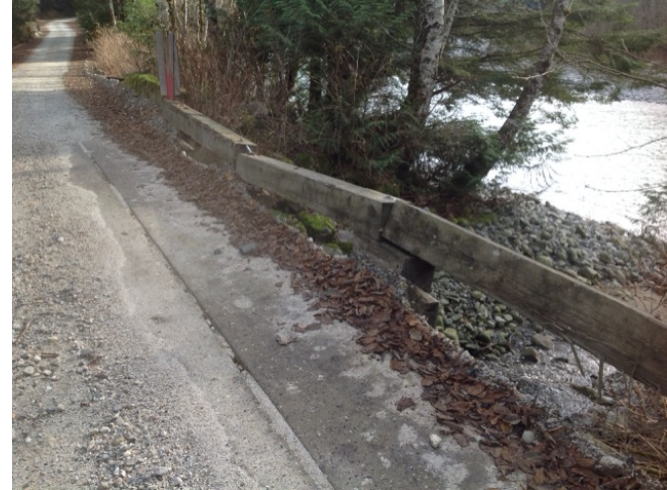
Guard Rail

Poor

rotten and broken

loose rail

| Repair Item | Priority | Repair Description |
|---|---|---|
| 1 | High | replace guardrail, risers and blocks |

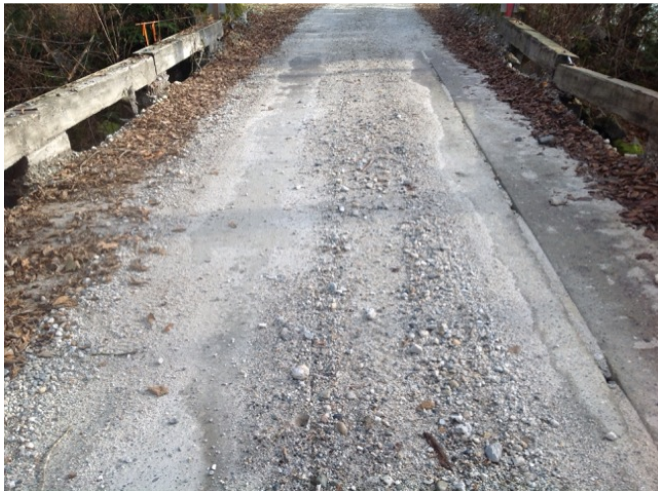
Deck

Fair

sediment on deck

| Repair Item | Priority | Repair Description |
|---|---|---|
| 2 | Medium | replace slab joint filler with approved manufacturer paraseal |

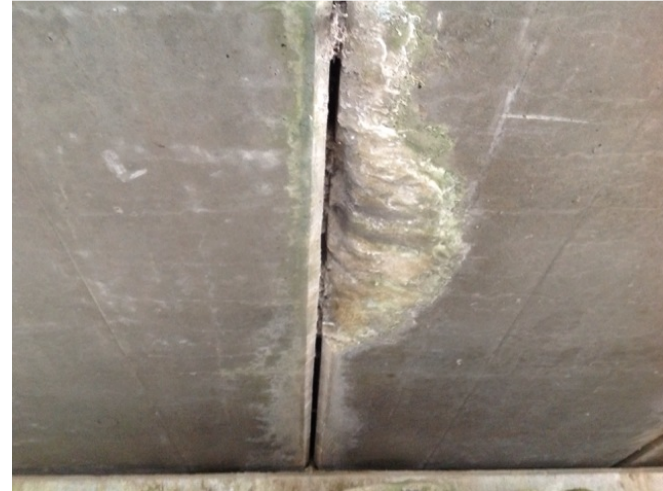
spalling under slab 2

| 1 | monitor spalling concrete underside of slab 2 | routine inspection |
