CK-2442

AMERICAN EIGHT 0.15km

2014 Inspection

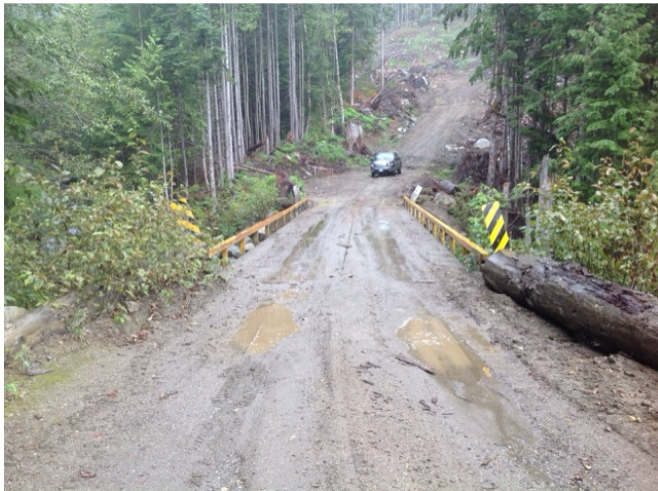
Approach from Right Bank when facing downstream

Road Surface Fair fair to poor as large pothole on right approach forming

| Repair Item | Priority | Repair Description |
|---|---|---|
| 2 | Medium | fill large pothole on right approach prior to hauling |
