CK-2446

NORRISH CREEK km

2014 Inspection

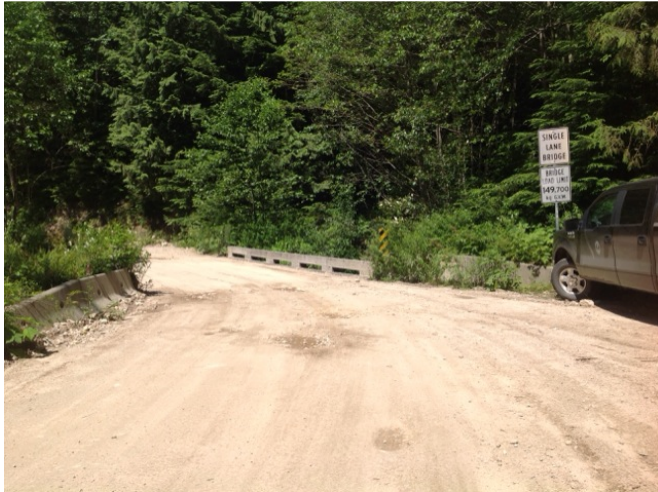
Approach from Left Bank when facing downstream

Brushing Required Y

Delineator Missing  
Left ☐ 0 ☒ 1 ☐ 2Delineator Missing  
Right ☒ 0 ☐ 1 ☐ 2

| Repair Item | Priority | Repair Description |
|---|---|---|
| 1 | Medium | brush approaches |
| 2 | Medium | replace missing delineator |

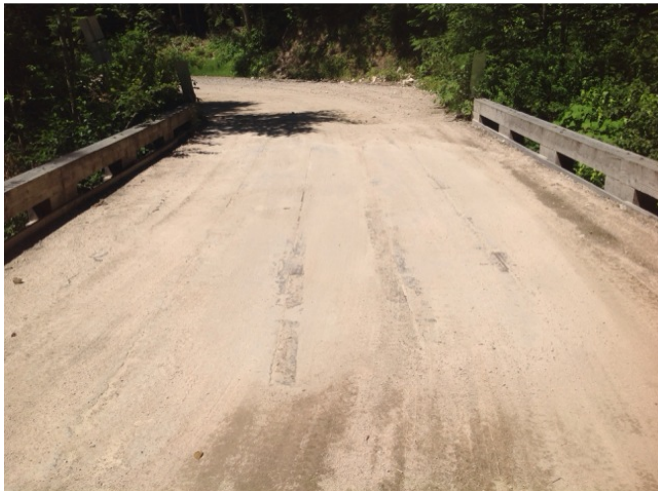
Concrete Deck Fair

Overall Deck Condition Fair

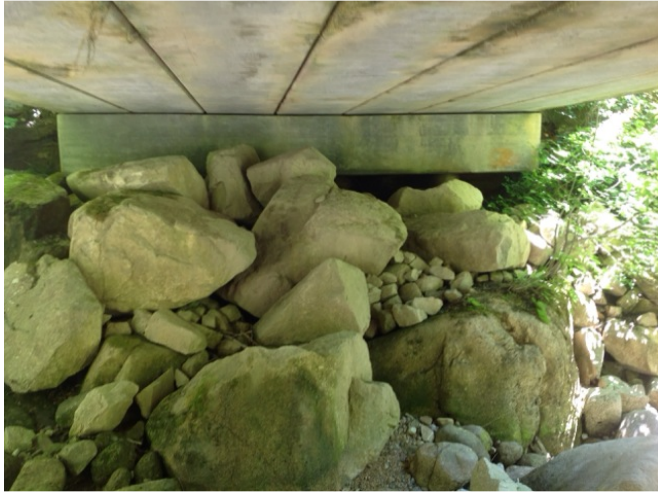
Left Bank Abutment when facing downstream

Fill Fair grouted under left pads

1 fill under left abutment footing pads
