CK-2448

NORRISH CREEK km

2014 Inspection

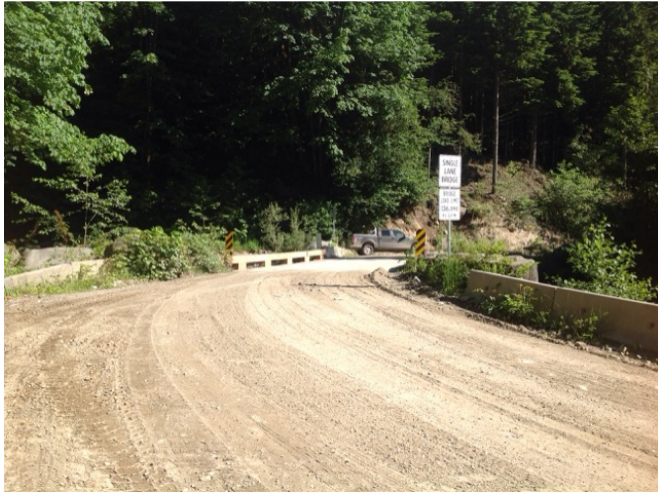
Approach from Right Bank when facing downstream

Delineator Missing  
Left ☐ 0 ☐ 1 ☒ 2 both delineators on left sides are actually right hands

| 2 | Medium | replace left hand delineators |

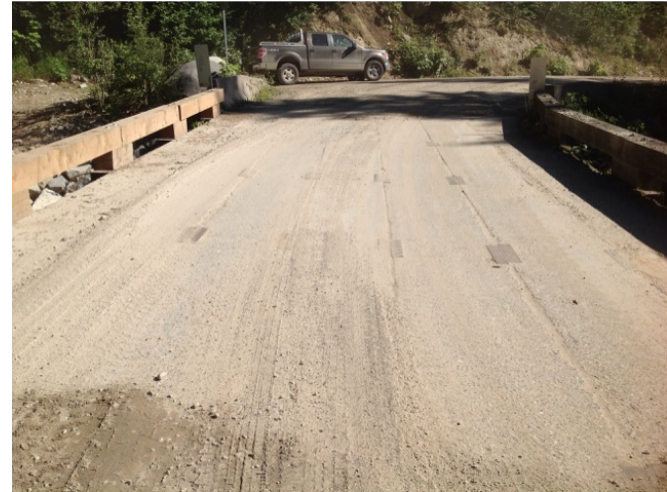
Curb Rail/Blocks/Posts Fair upstream is new and tight, downstream fair to poor

Overall Deck Condition Fair

Downstream guardrail will need to be replaced soon. Provide 175mm gravel surfacing over the concrete slabs extending into the approaches as per the original design. Present load rating of L150 or 136 tonnes to continue.

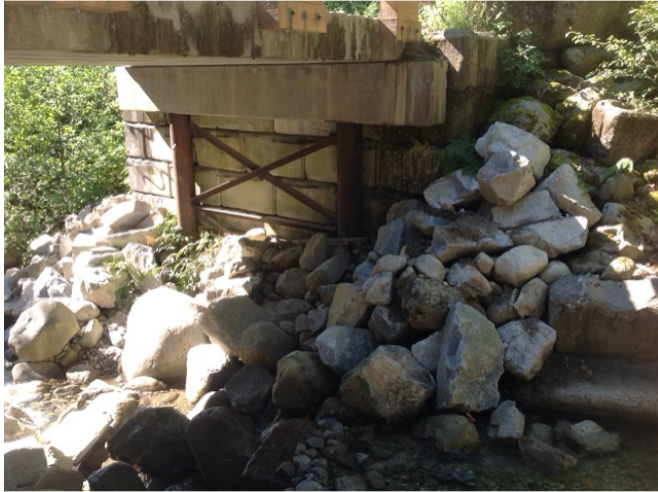
Right Bank Abutment when facing downstream

Piles or Posts Fair not painted, 2 bays right side

Corrosion Protection Poor not painted

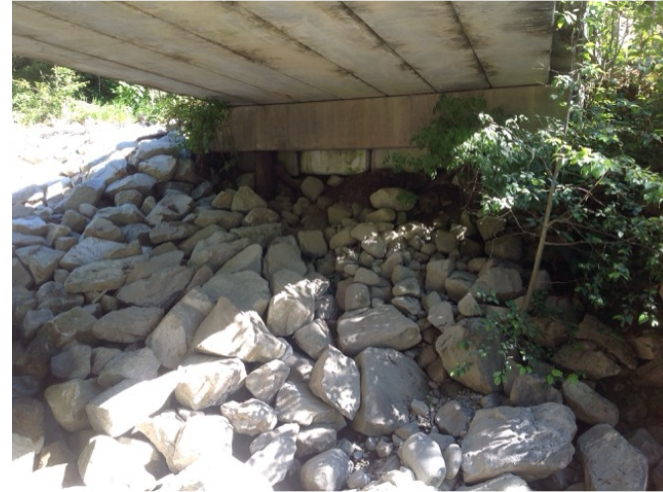
Left Bank Abutment when facing downstream

Ballast Wall Fair lock blocks, differential settlement left side (no levelling pad)

| 2 | lock block settlement | |

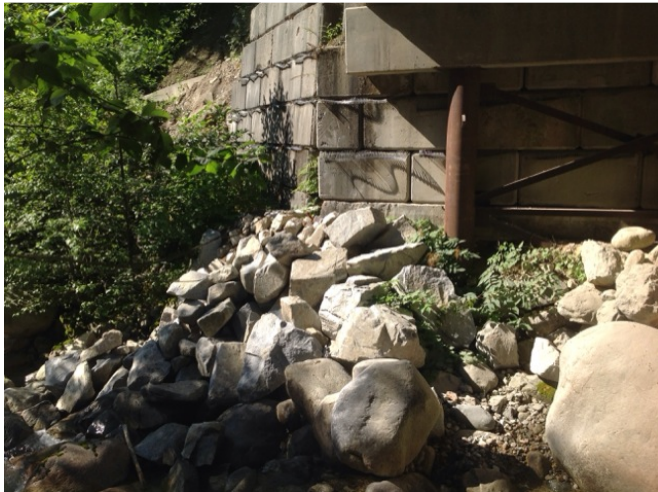
right downstream wing wall

Wing WallBracing Fair lockblocks downstream right side

Comment recent riprap added to protect both abutments and downstream right wingwall

| 1 | scour | |
