CK-2450

NORRISH CREEK km

2014 Inspection

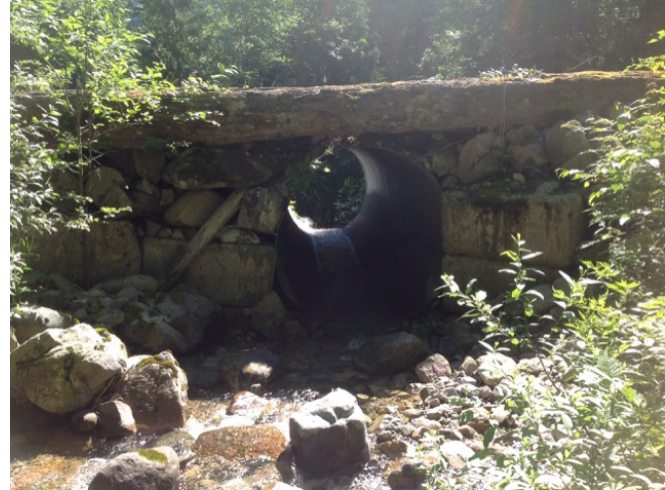
| Inlet | Fair | |

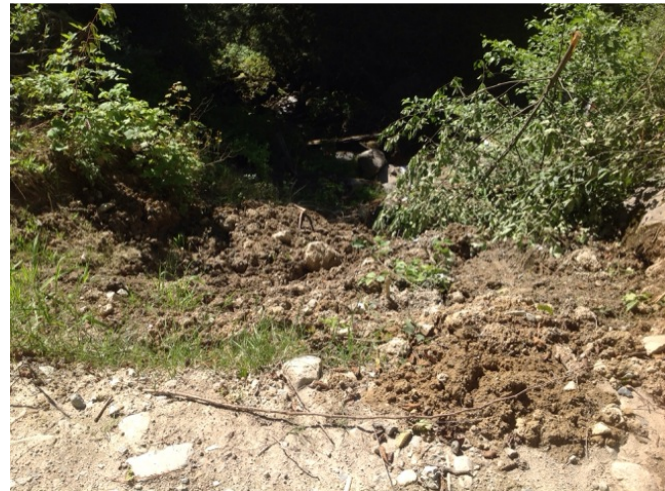
| Fill | Fair | fair to poor, 0.3m fill over culvert and eroding downstream at both approaches |

left downstream approach fills

| 2 | fill slopes on either approach | Anually |

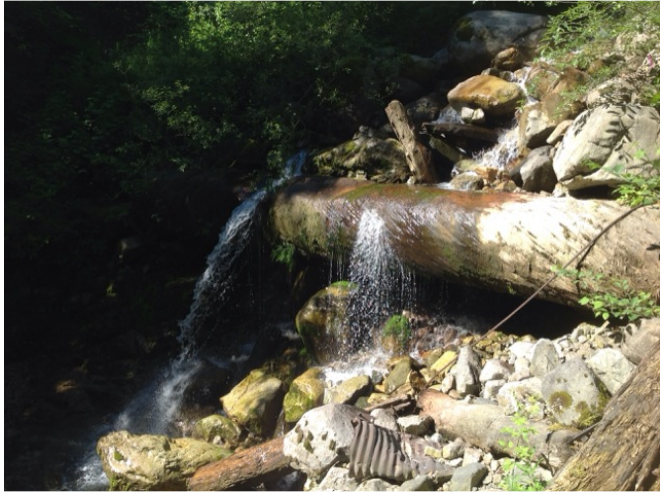
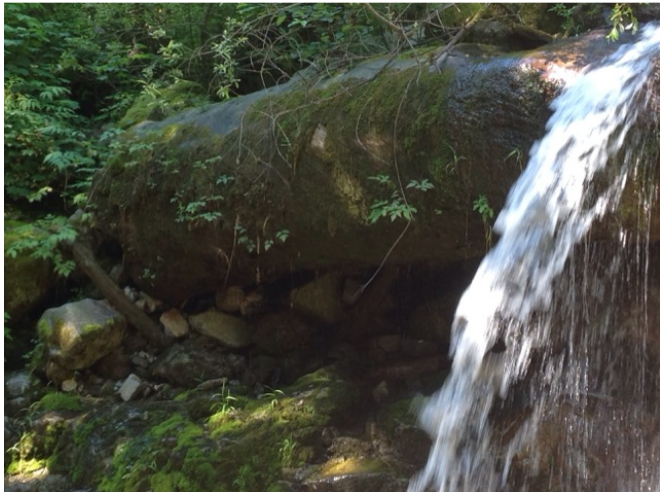
| Outlet | Poor | steep and log holding fill approx 5 meters below |
| Overall | Poor | due to outlet condition |

log holding back fill

| 1 | log holding fill | Anually |
