CK-2451

NORRISH CREEK 5.6km

2014 Inspection

| Structure Class | Major Culvert |

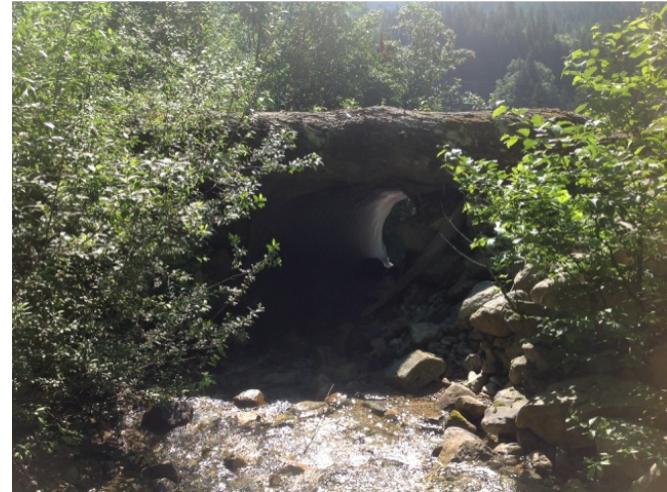
| Inlet | Fair | damaged but functional |

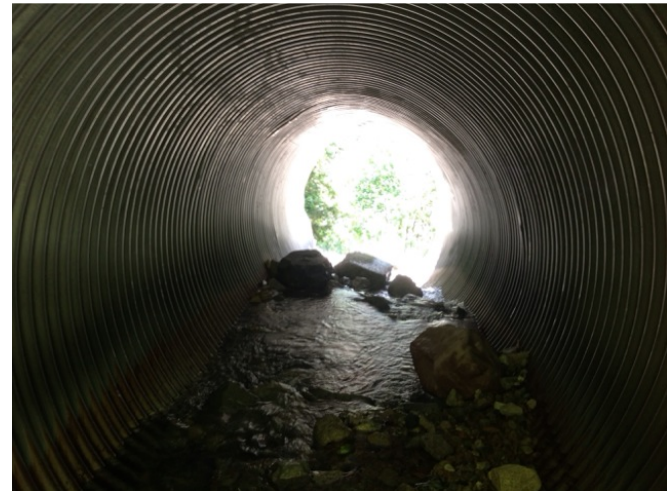
looking through culvert

| Floor | Poor | damaged |
| Sidewalls | Poor | damaged |

1 culvert shape

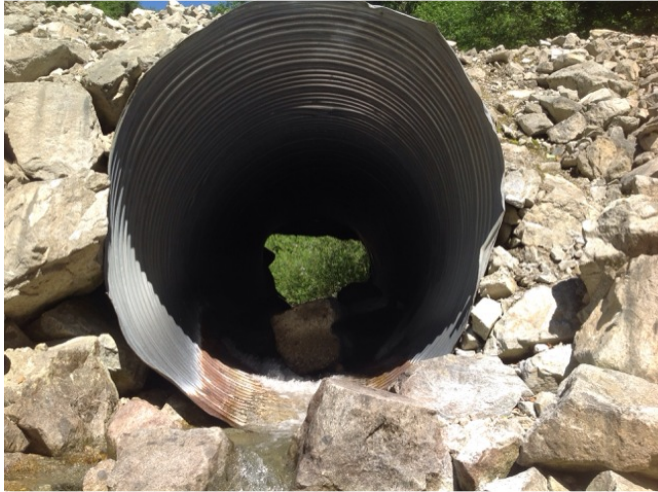
| Outlet | Fair | damaged but functional |
