CK-2452

NORRISH CREEK km

2014 Inspection

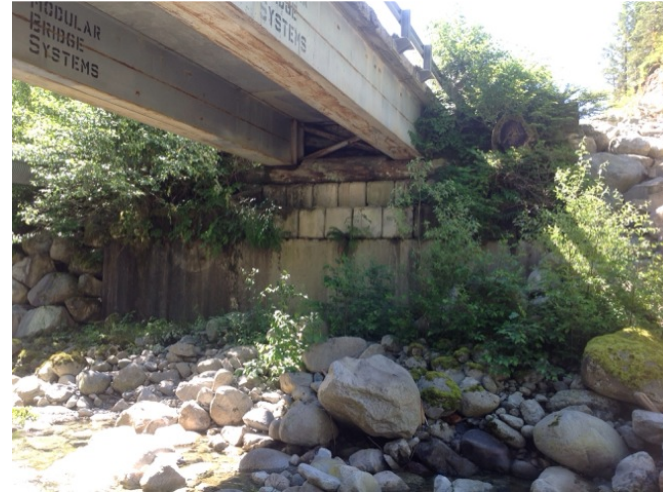
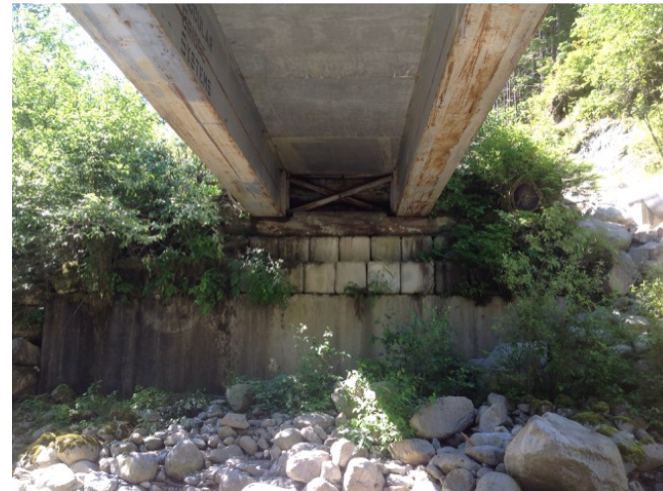
Right Bank Abutment when facing downstream

Caps or Sills Fair right bank, single log sill

Riprap Poor none in front of either abutment

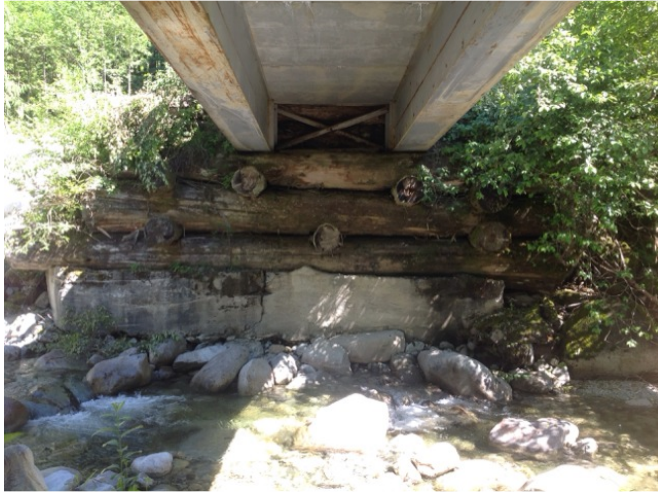
Left Bank Abutment when facing downstream

Log/Timber Cribs Fair left bank only, on top of CIP

Concrete Fair vertical crack on left CIP

Monitor left bank abutment condition and deck joints. Present load rating of L165 or 150 tonnes to continue.

| 2 | left bank abutment condition | Routine Inspection |
