CK-2453

NORRISH CREEK km

2014 Inspection

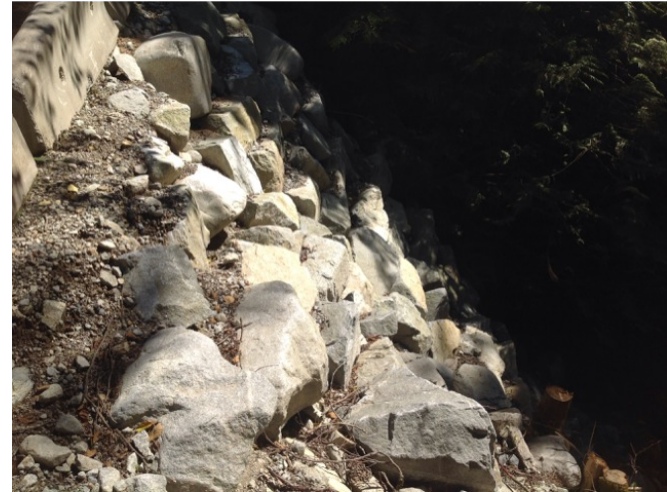
right bank fill slope

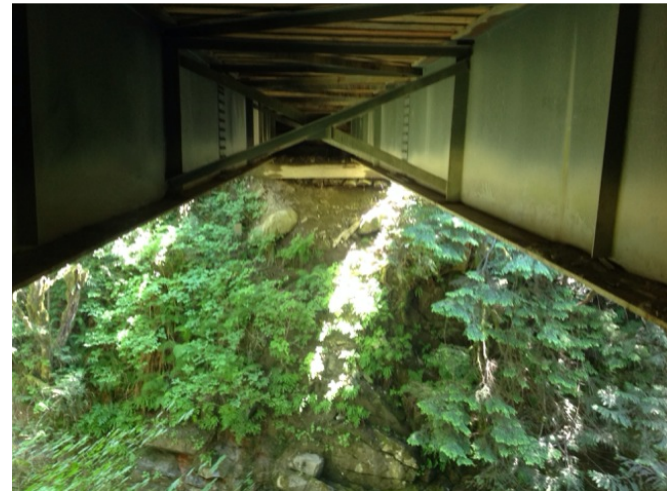
Left Bank Abutment when facing downstream

Monitor left bank fill, in front of log sill. Present load rating of L100 or 91 tonnes to continue.

Fill Fair eroding at left abutment - monitor

1 left bank fill in front of bearing
