CK-2454

NORRISH CREEK km

2014 Inspection

Structure Class Major Culvert

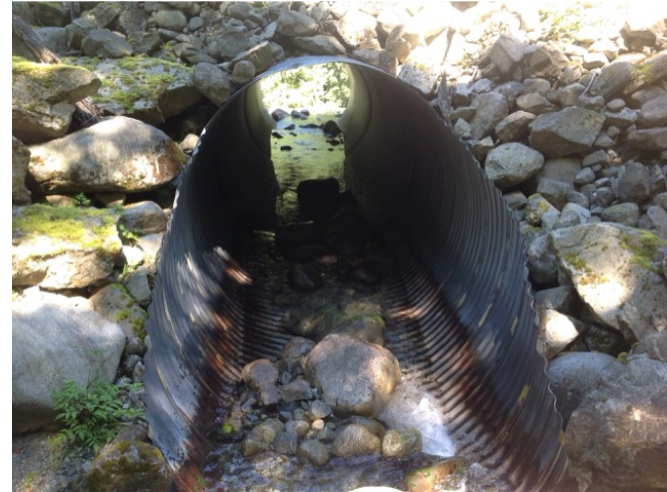
| Inlet | Fair | material starting to enter culvert |

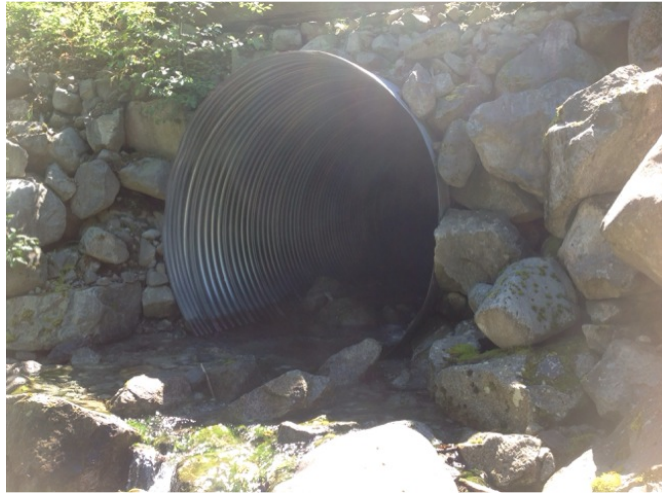
| Outlet | Good | |
