CK-2455

NORRISH CREEK km

2014 Inspection

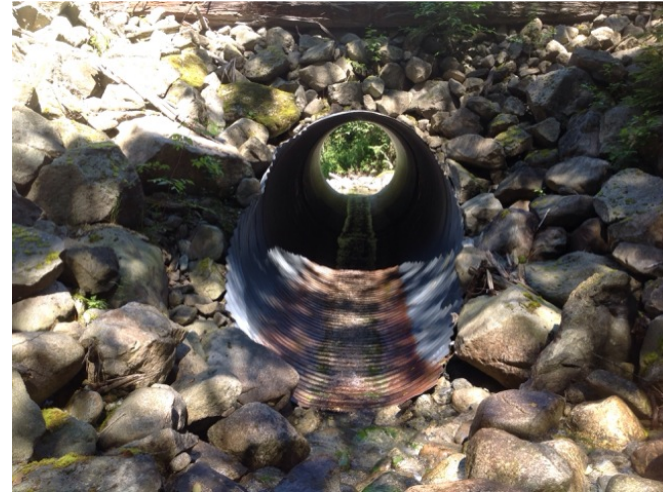
Inlet Good

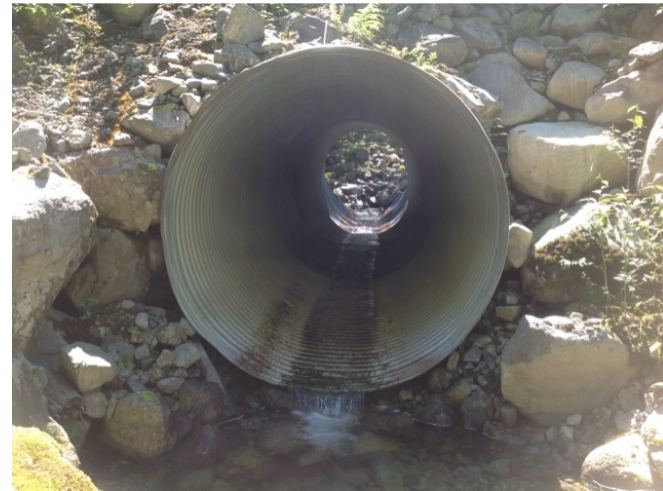
Outlet Good
