CK-2456

NORRISH CREEK km

2014 Inspection

Structure Class Major Culvert

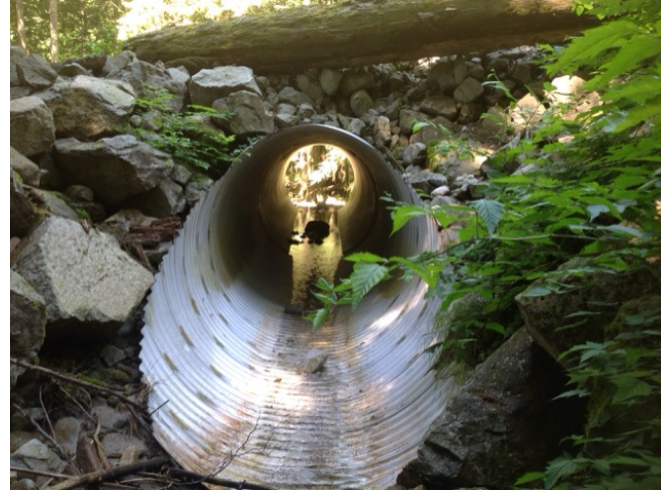
| Inlet | Good |

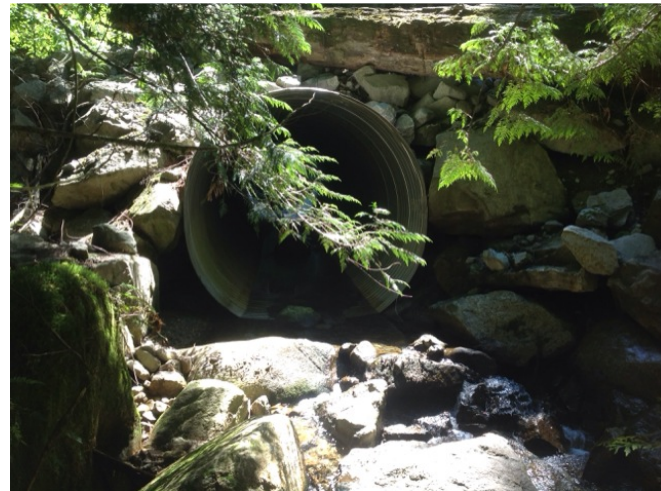
| Outlet | Good |
