CK-2457

NORRISH CREEK km

2014 Inspection

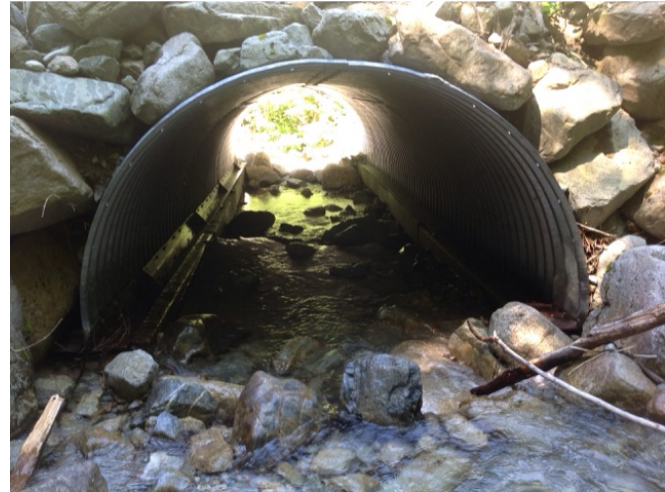
| Inlet | Fair | |

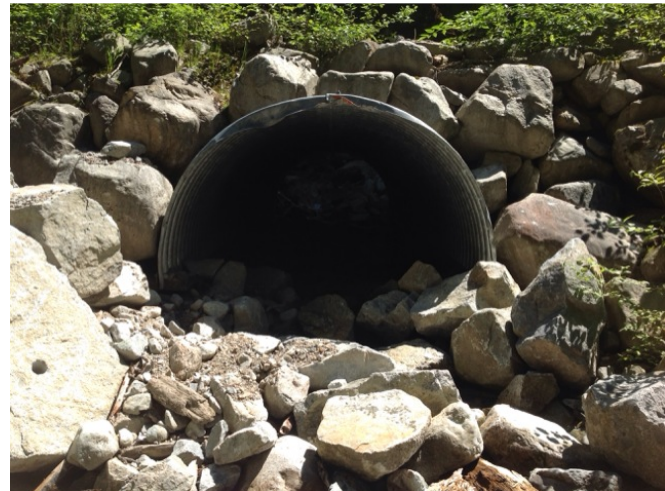
| Outlet | Fair | |

Comment ~ material flushing from culvert, recent work completed to outlet to help hold material from flushing needs to be monitored - rock does not appear to have been sunk into the stream and rather just placed across it

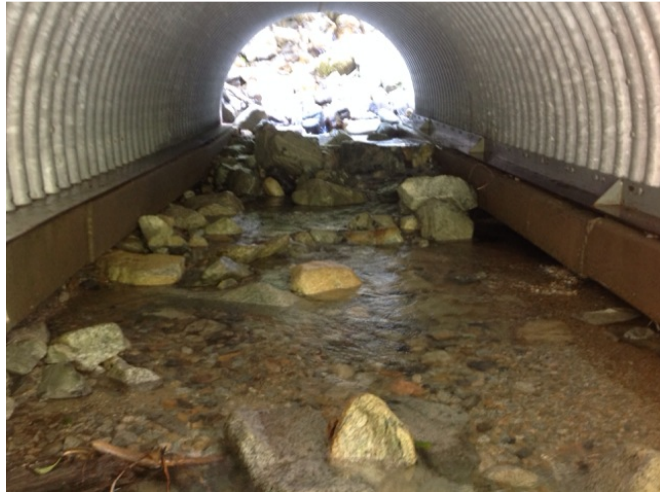
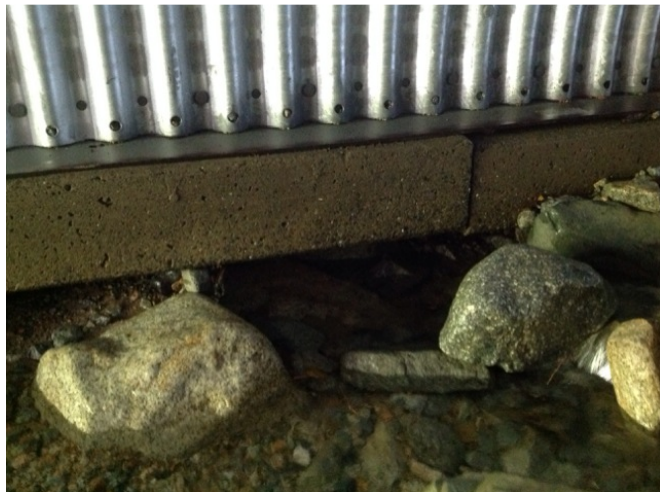
| Footing | Poor | concrete footing pads scoured, not proper bearing |

Monitor material from flushing out of the culvert and the poor bearing condition of the concrete footing pads. If material continues to flush from the culvert or the footing pads continue to be scoured then I recommend a complete reinstall of the structure. BCL-625 or 63 tonnes load rating, please post.

| 2 | scour under concrete footing pads | Other |
