CK-2458

NORRISH CREEK km

2014 Inspection

Structure Class Major Culvert

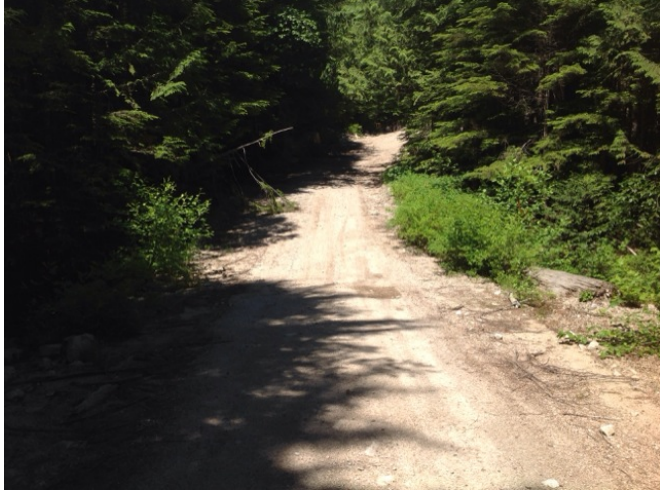
Approach from Left Bank when facing downstream

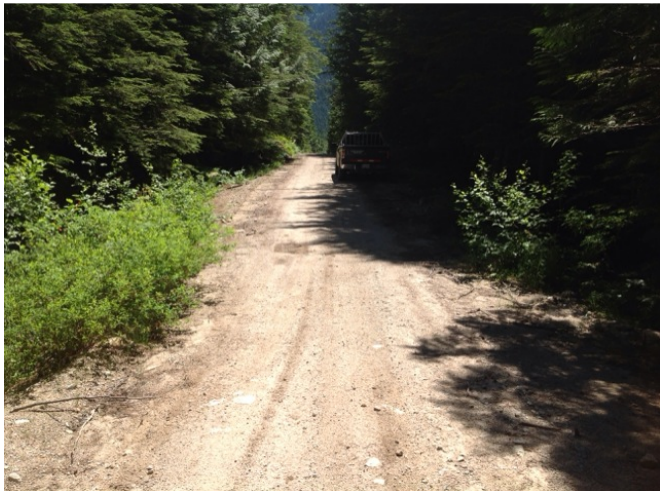
Approach from Right Bank when facing downstream

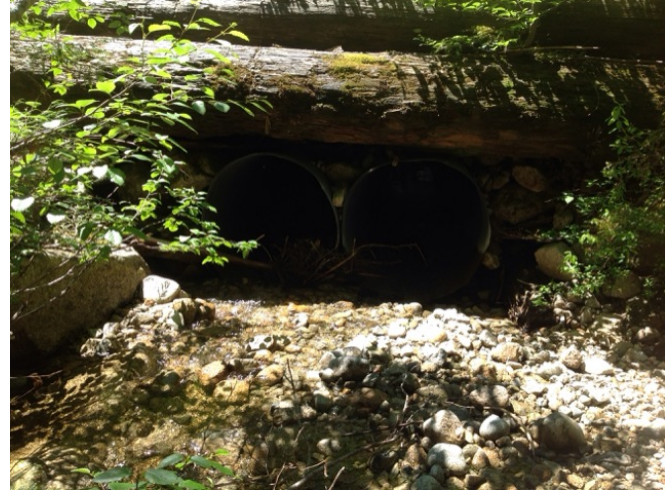
| Inlet | Fair | |

Aggradation ☒Scour ☐

1 inlet for aggradation

Monitor inlet aggradation. Present load rating of L100 or 91 tonnes to continue.

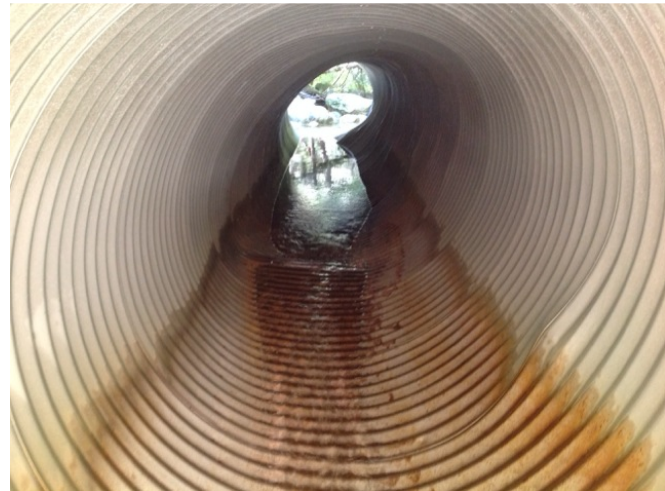
| Roof | Poor | both culverts have dented roofs and sidewalls |
| Sidewalls | Poor | both culverts have dented roofs and sidewalls |

inside culvert
