CK-2462

HORNET CREEK km

2014 Inspection

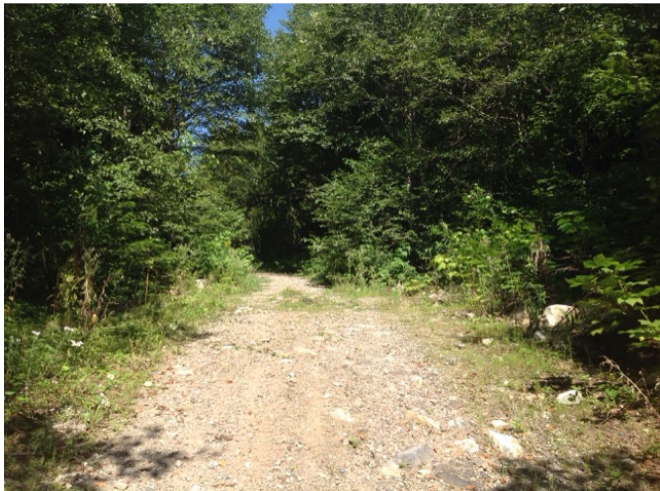
Approach from Left Bank when facing downstream

Alignment Fair steep VC left approach

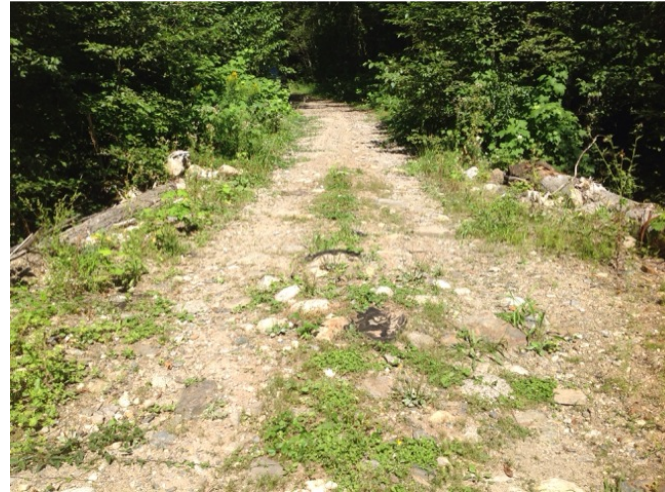
Curb Rail/Blocks/Posts Poor too low

Overall Deck Condition Poor due to shallow gravel depth and curbs
