CK-2466

GARNET CREEK km

2014 Inspection

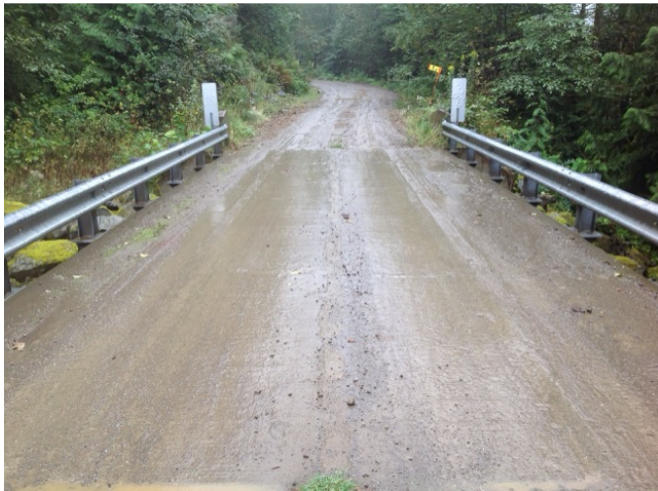
Overall Deck Condition   Fair

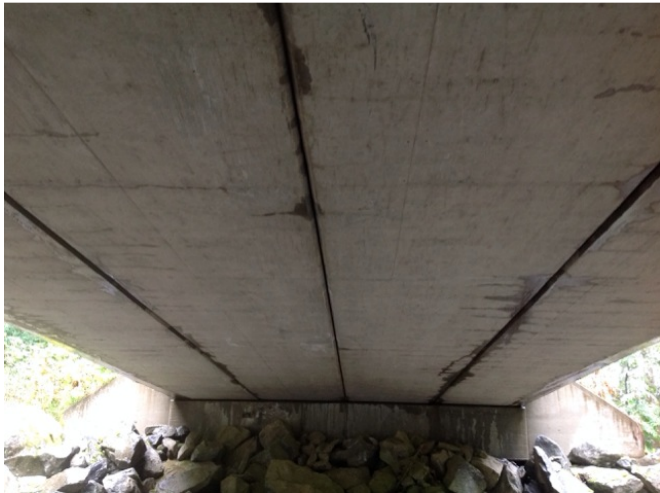
Girders    Good            4 slabs

Welded/grouted shear connectors    Fair            grout
