CK-2471

CHEHALIS-MAISAL km

2014 Inspection

| Structure Class | Major Culvert |

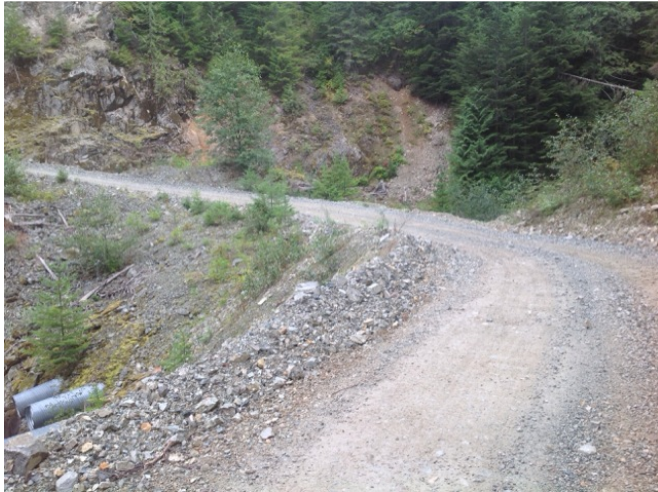
Approach from Left Bank when facing downstream

tight HC both approaches

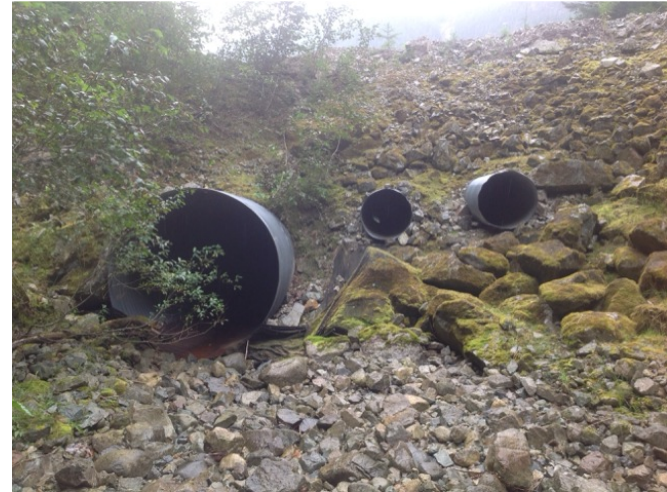
Inlet Fair

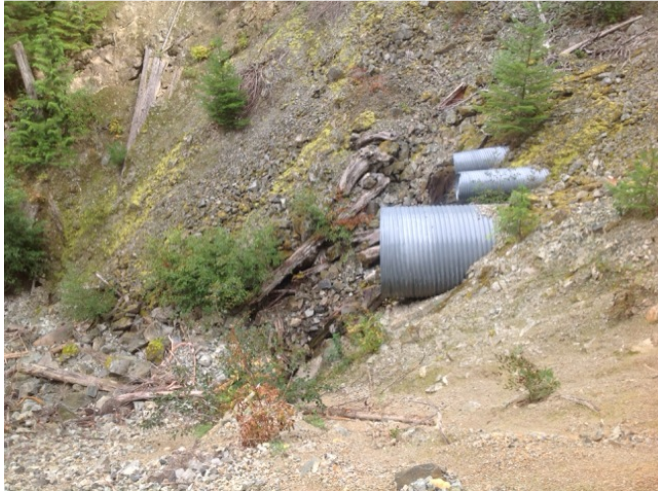
Outlet Fair 5.0 drop at outlet but well armoured
