CK-2488

STS'AILES km

2014 Inspection

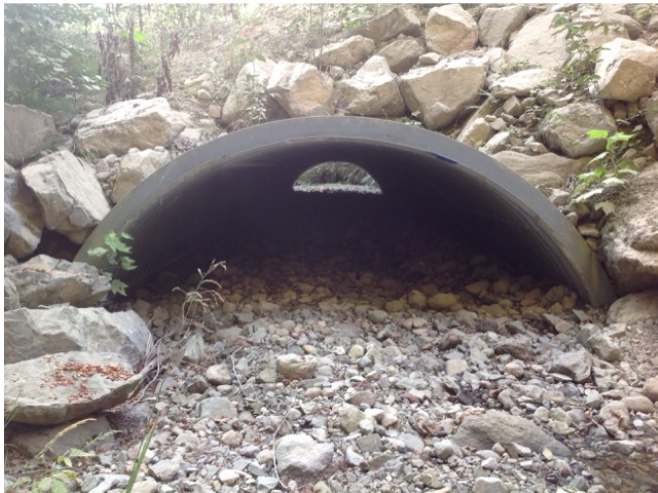
Inlet Good 1200mm freeboard

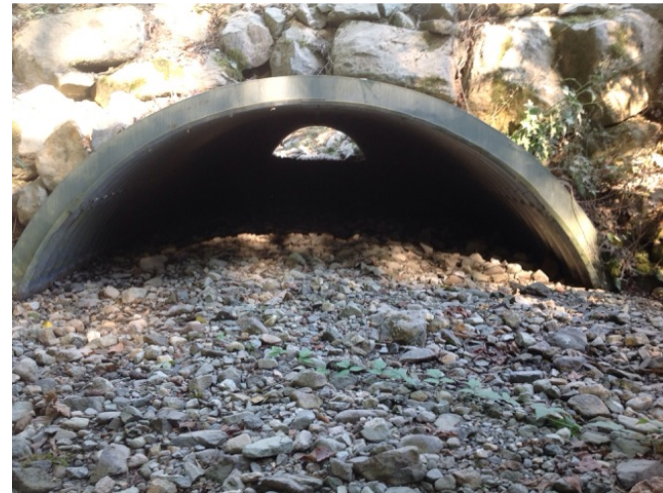
Outlet Good 1000mm freeboard
