CK-2489

BENCH 7.2km

2014 Inspection

Major Culvert

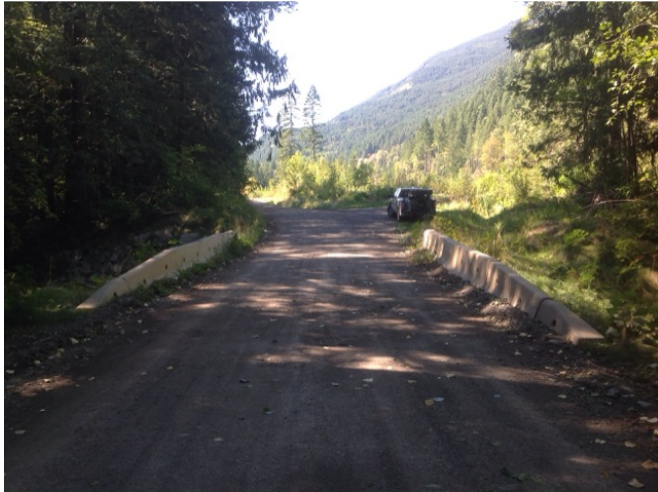
Approach from Left Bank when facing downstream

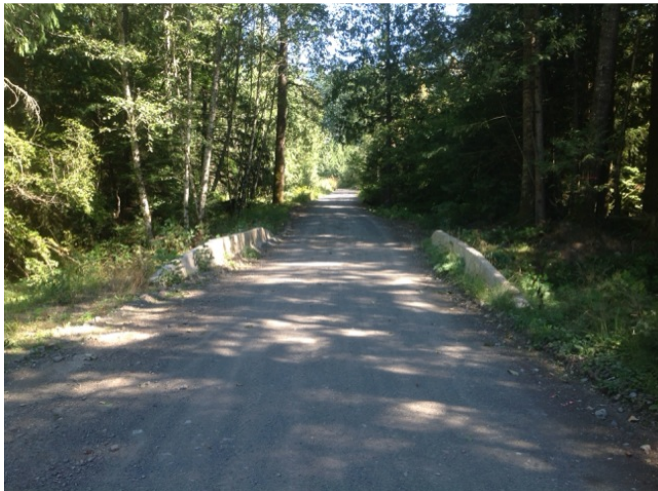
Approach from Right Bank when facing downstream

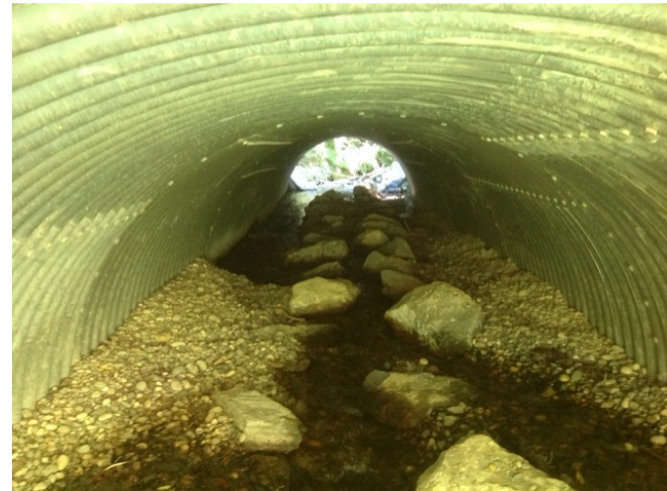
Embedment Materials Fair some of the fill within the culvert has washed out but footing still in tact (wrapped in geogrid and geotextile)

inside culvert

1 fill within culvert

Routine Inspection
