CK-2498

FOLEY CREEK 0.1km

2014 Inspection

Foley Creek

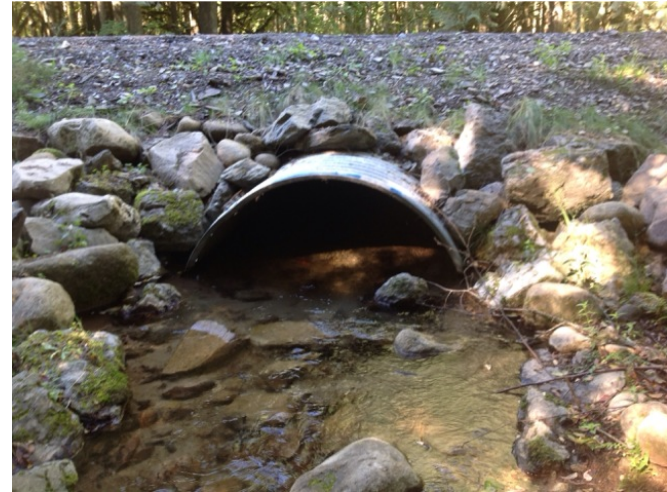
Inlet Good

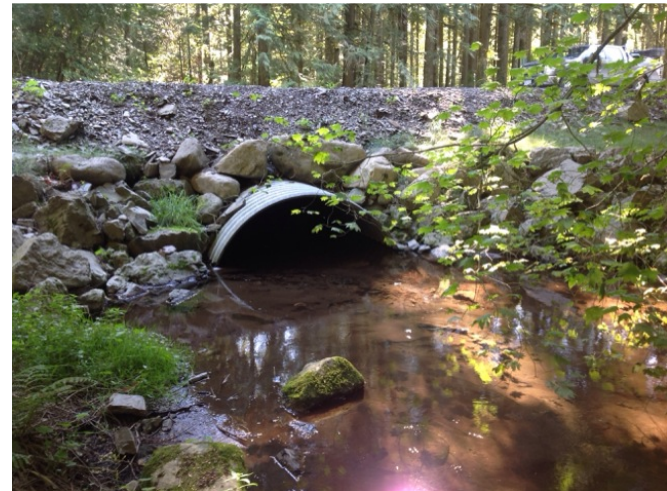
Outlet Good
