CK-2499

BENCH km

2014 Inspection

Structure Class Major Culvert

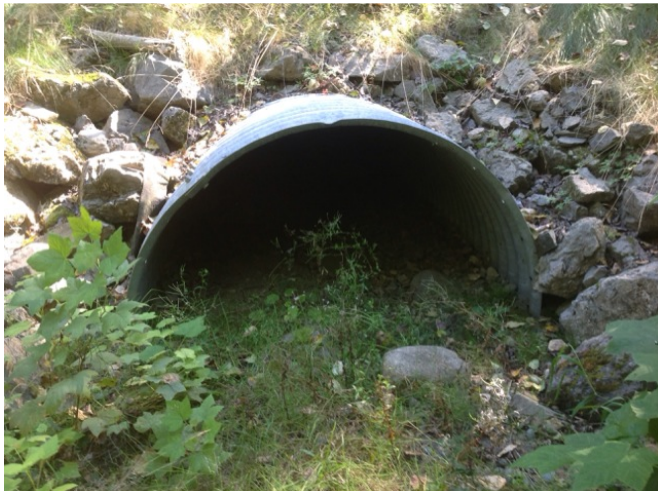
Inlet Good

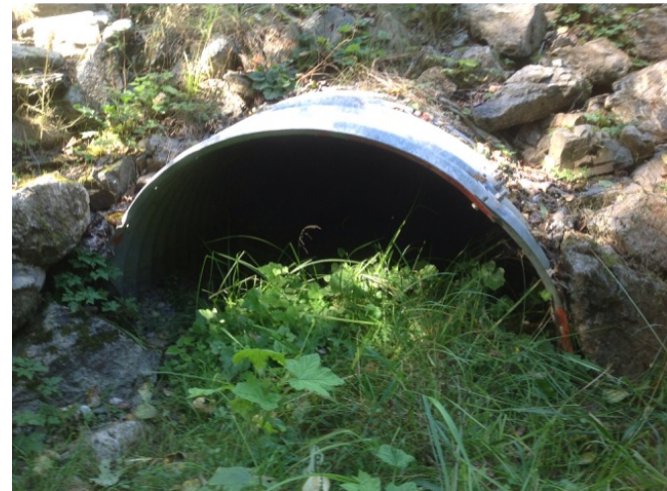
Outlet Good
