CK-2502

CHEHALIS-FLEETWOOD 7km

2014 Inspection

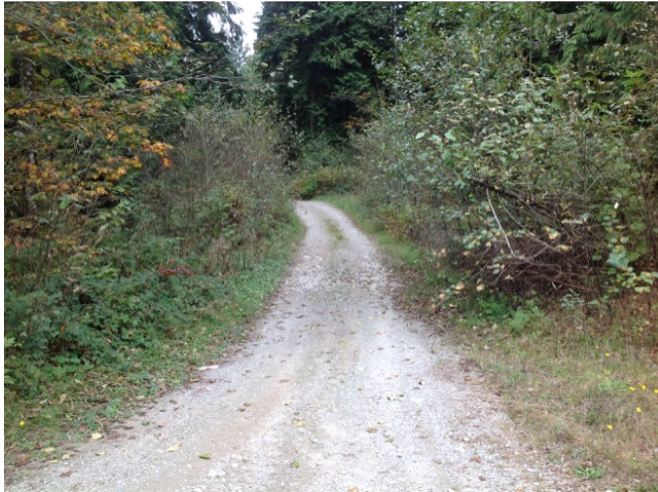
Approach from Left Bank when facing downstream

Alignment Fair

Bridge Ahead Signs  
Missing ☐ 0 ☐ 1 ☒ 2

Brushing Required Y

Delineator Missing  
Left ☐ 0 ☐ 1 ☒ 2Delineator Missing  
Right ☐ 0 ☐ 1 ☒ 2

Fender Condition Poor none

| Repair Item | Priority | Repair Description |
|---|---|---|
| 1 | Medium | brush and post bridge ahead signs and replace missing delineators |
| 3 | Medium | place log fenders |

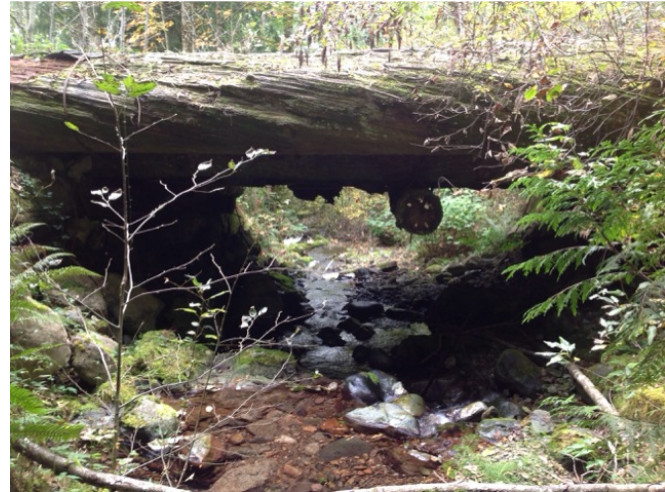
Upstream Profile

Curb Rail/Blocks/Posts Poor too low upstream, and nonexistent downstream

Log Curbs    Poor    too low and not connected to needle beam or stringers

| Repair Item | Priority | Repair Description |
|---|---|---|
| 2 | High | place new curbs and lash to stringers before use |

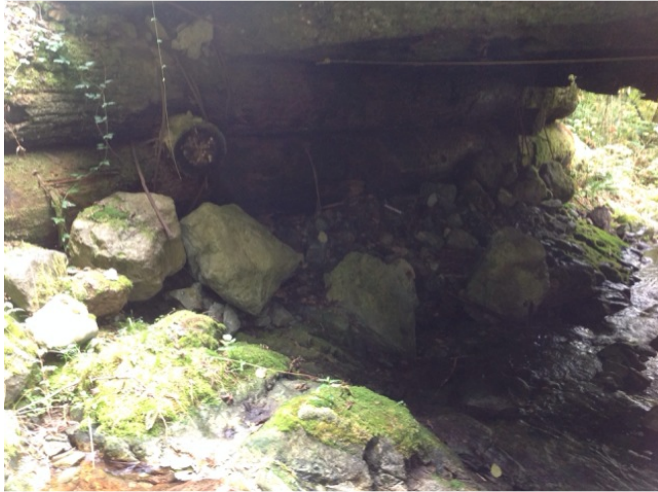
Left Bank Abutment when facing downstream

Log/Timber Cribs Fair 2x

Tie Backs Fair 2x

Hardware Fair crib lashed
