CK-2505

MURDO SIXTEEN 0.4km

2014 Inspection

| Structure Class | Woodbox/Log Culvert |

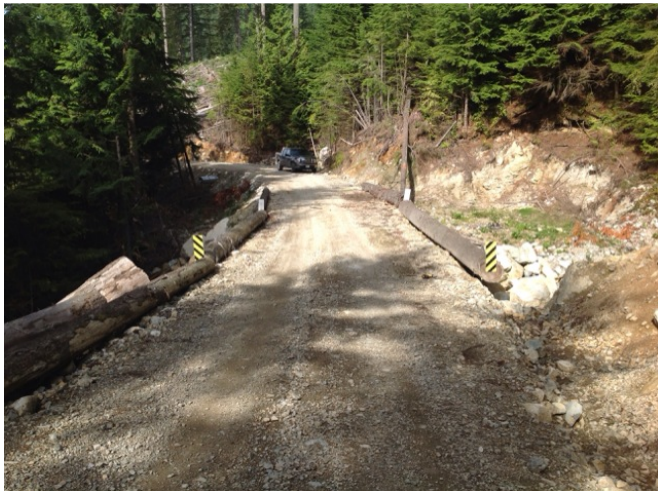
Approach from Left Bank when facing downstream

missing left upstream

| Repair Item | Priority | Repair Description |
|---|---|---|
| 2 | Medium | replace missing upstream left guide log |

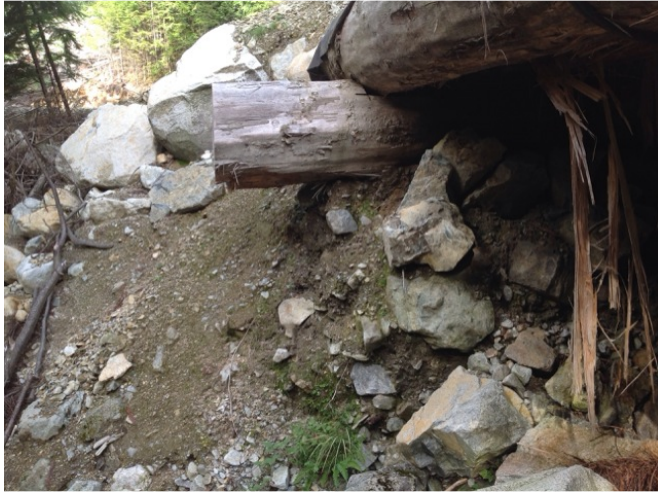
Replace missing guide log on upstream left approach. Post bridge ahead signs. Monitor the fill on the outlet of this structure. The sill logs ends are already scoured and the remaining fill is over-steepened. If any more scour has taken place then what is pictured in this inspection the hauling should be stopped and a repair plan determined. Present load rating of L120 or 109 tonnes to continue.

poor on the outlet - requires monitoring

right downstream abutment scour

1 outlet fill erosion and abutment (log sill) scour

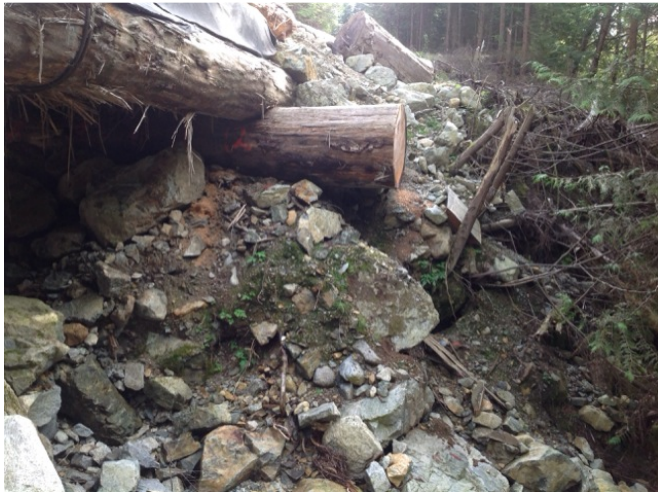
left downstream scour
