CK-2509

CHEHALIS-STATLU km

2014 Inspection

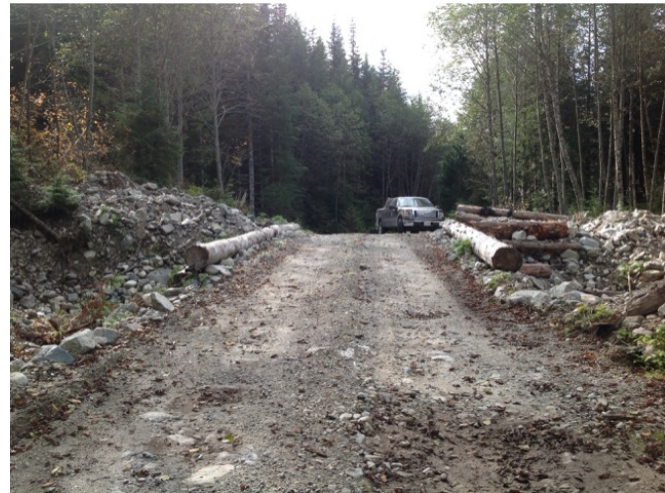
Approach from Right Bank when facing downstream

missing right approach fenders

| Repair Item | Priority | Repair Description |
|---|---|---|
| 2 | Medium | replace missing fenders |
