CK-2199

NAHATLATCH 30.3km

2014 Inspection

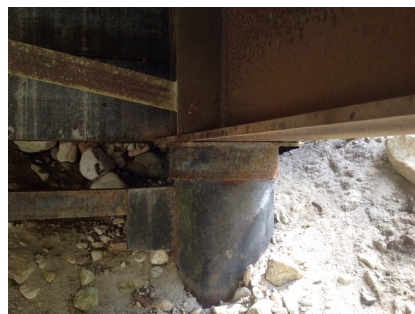
Caps or Sills    Fair

steel ring

- 5 steel bearing  
ring
