CK-2320

NAHATLATCH 19.1km

2014 Inspection

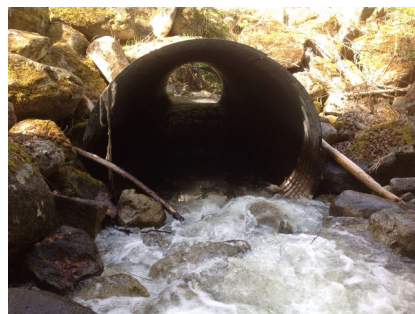
- 5 Inlet

| Inlet | Good | |

Comment monitor aggradation at inlet

1 aggrading inlet

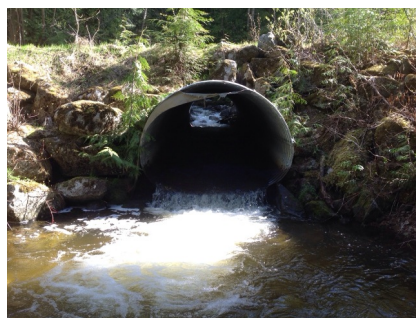
| Outlet | Fair | 0.3 plunge pool |

2 outlet scour
