CK-2475

NAHATLATCH km

2014 Inspection

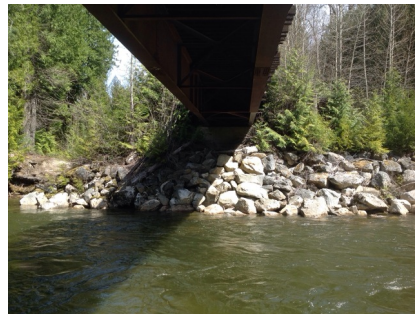
- 3 Right Bank  
Abutment when  
facing  
downstream

Ballast Wall Fair treated timbers left side, treated timbers and concrete right

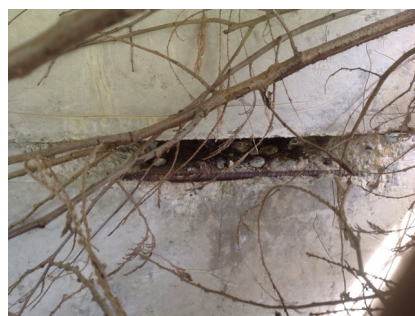
- 5 right bottom  
ballast wall

| 1 | monitor right bottom ballast wall damage (concrete) | Routine Inspection |

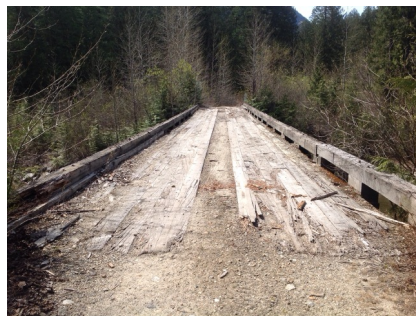
Running Planks Poor rotten, replace

Nails Poor protruding

Curb Rail/Blocks/  
Posts Poor rotten

Hardware Poor loose rail

Overall Deck  
Condition Poor due to planks and rail

| Repair Item | Priority | Estimate | Repair Description |
|---|---|---|---|
| 1 | High | | replace running planks, guardrail and risers |
