CK2477

NAHATLATCH 39.8km

2014 Inspection

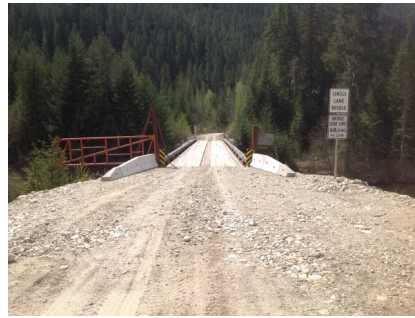
- 1 Approach from  
Left Bank when  
facing  
downstream

wrong load rating sign

| Repair Item | Priority | Estimate | Repair Description |
|---|---|---|---|
| 1 | Medium | | Replace incorrect load rating sign |

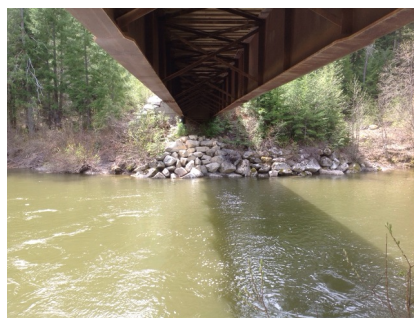
Right Bank  
Abutment when  
facing  
downstream

treated timbers - monitor right bank D/S as fill is pushing it out

| 1 | right D/S ballast wall | Routine Inspection |
