CK2479

NAHATLATCH GRIZZLY km

2014 Inspection

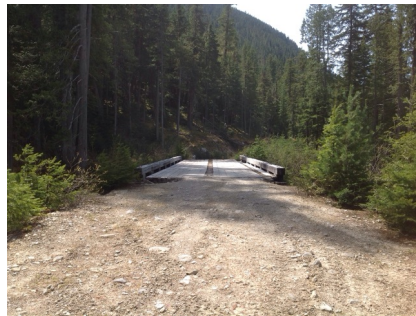
- 3 Approach from  
Right Bank  
when facing  
downstream

Fill Poor poor on right approach, fair other

| Repair Item | Priority | Estimate | Repair Description |
|---|---|---|---|
| 1 | Medium | | repair fill right approach prior to activity |
