2495

STS'AILES 1.2km

2014 Inspection

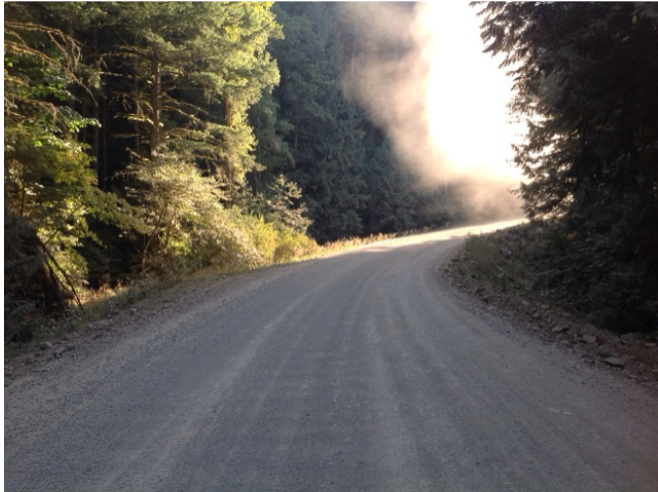
Approach from Right Bank when facing downstream

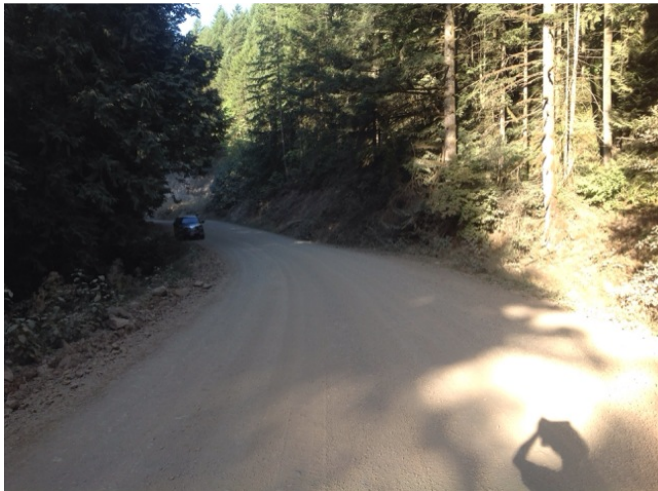
Approach from Left Bank when facing downstream

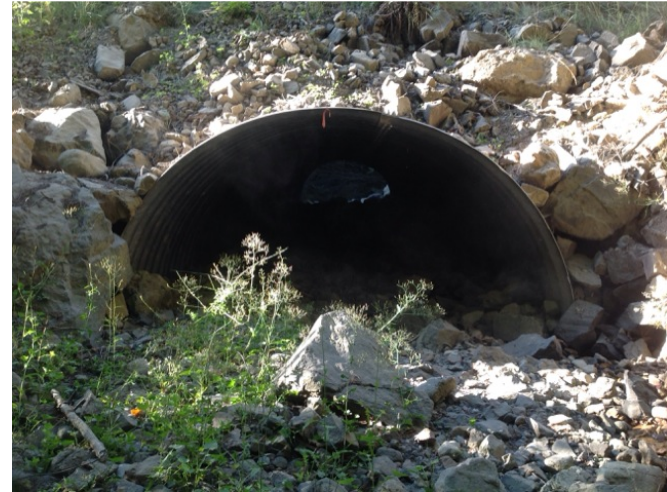
Inlet Good

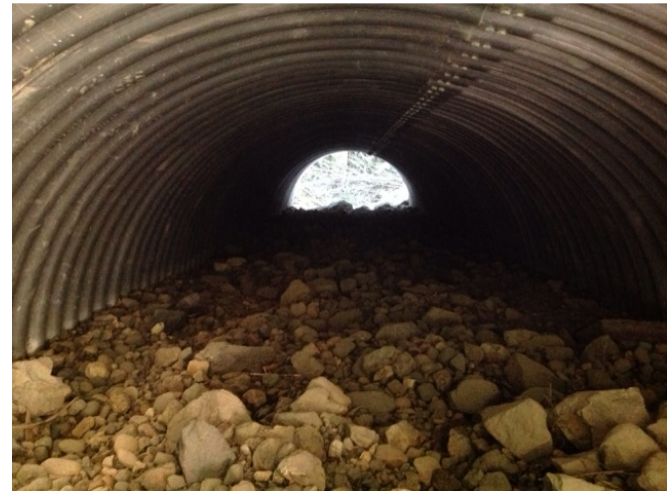
inside culvert

1 roof has 2 slight depressions in roof from installation

Routine Inspection

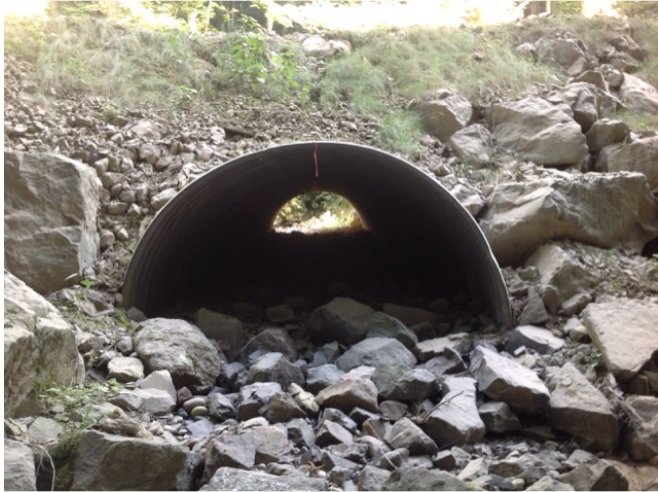
Outlet Fair
