CK-2003

AMERICAN CREEK 8.5km

2015 Inspection

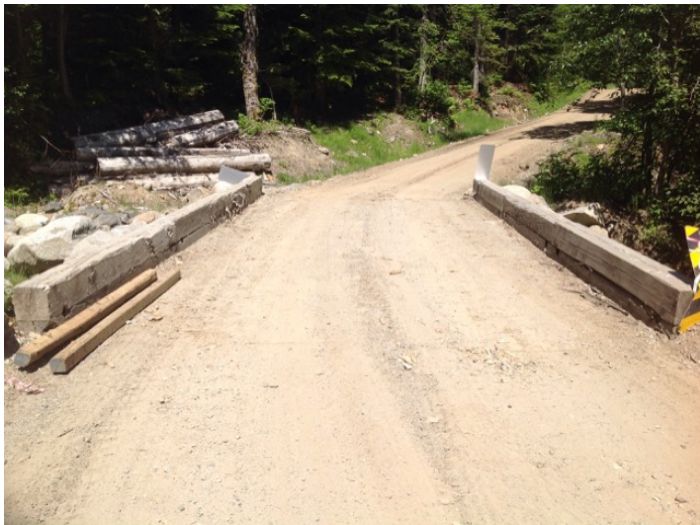
Overall Deck Condition Fair
