CK-2011

BLUE MTN TWO 0.1km

2015 Inspection

| Crossing Name | Copper Creek |

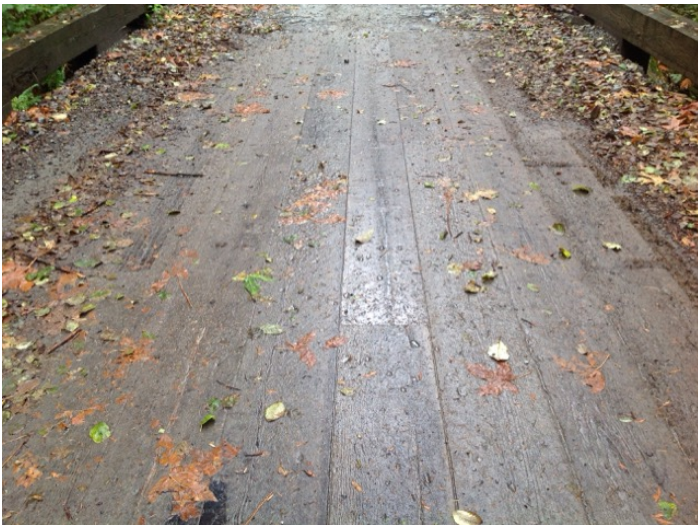
Overall Deck Condition Good

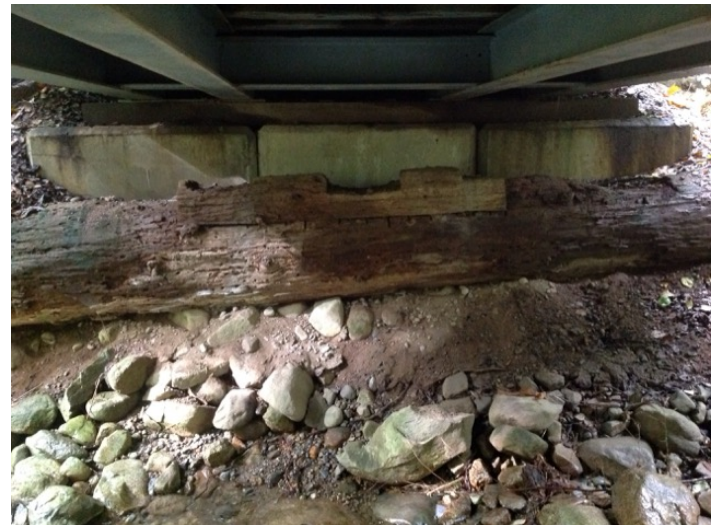
Right Bank Abutment when facing downstream

Concrete Good 3 lock blocks per abutment

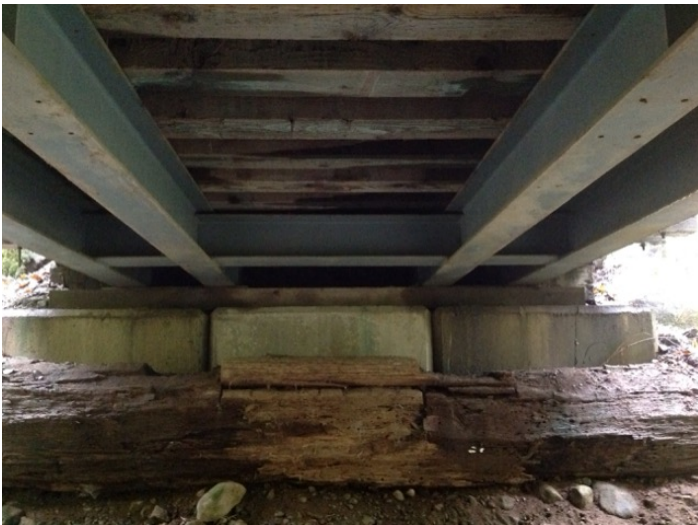
superstructure

Girders Fair 4 painted steel I beams

Bracing Fair painted
