CK-2019

CAYOOSE CREEK 0.1km

2015 Inspection

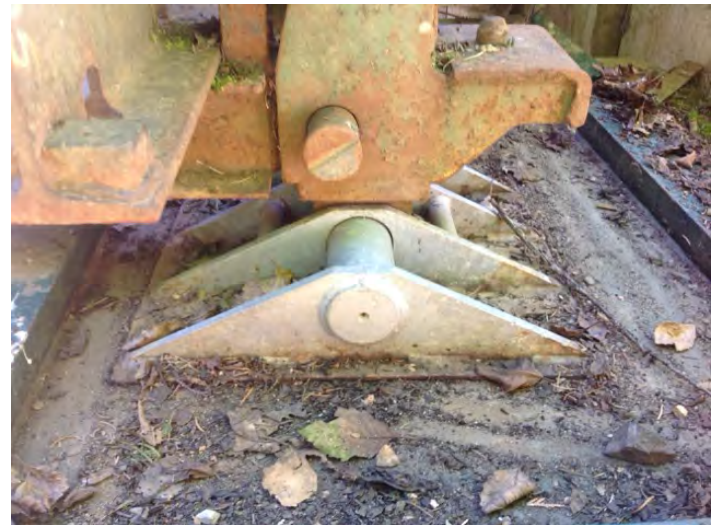
end post bearing - typical

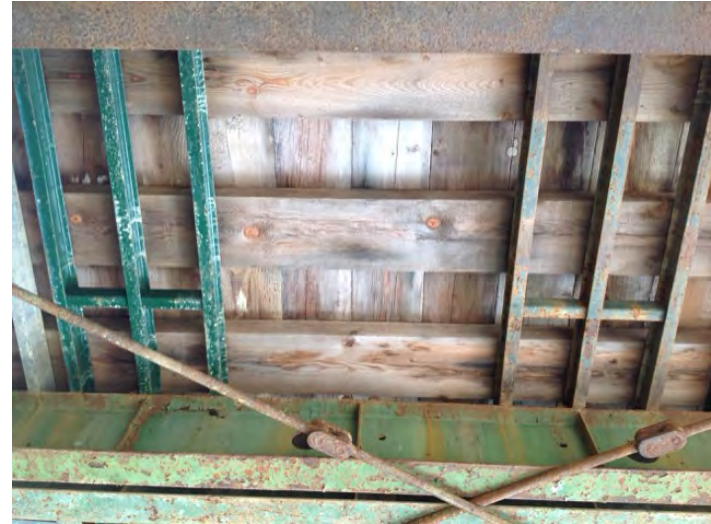
missing steel stringers in 2 separate locations , 20 feet total

Replace missing cotter pins and delineators prior to industrial activity. The deck is nearing the end of its industrial life (8 years old). When the deck is replaced, replace the 2 missing steel stringers. Brush approaches and replace bridge ahead signs. Present load rating of CL-625 or 63 tonnes to continue.

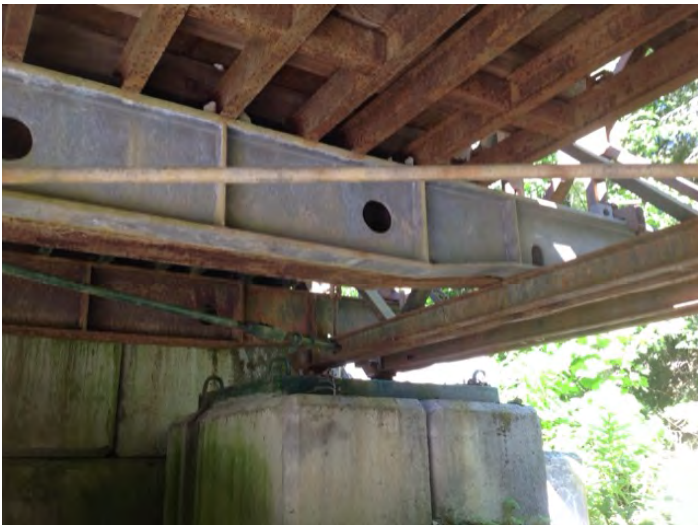
paired transom - typical

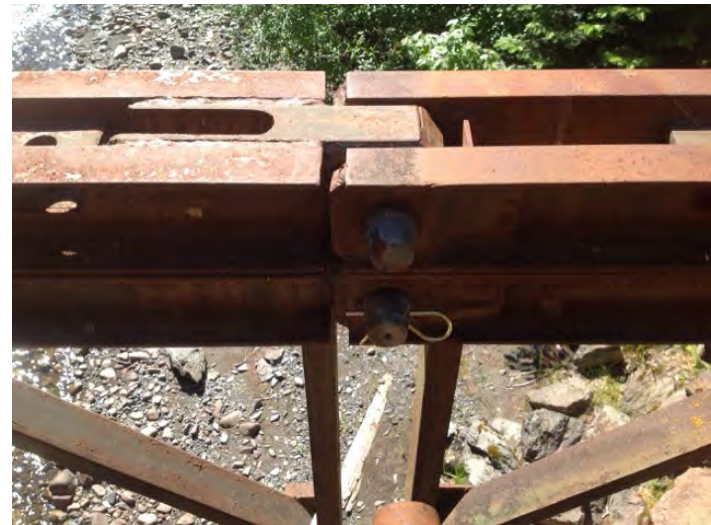
Hardware Fair missing a total of 58 cotter pins

53 missing cotter pins on top  
3 missing cotter pins on bearing  
2 missing cotter pins on bottom

| 1 | High | replace all missing cotter pins prior to activity |

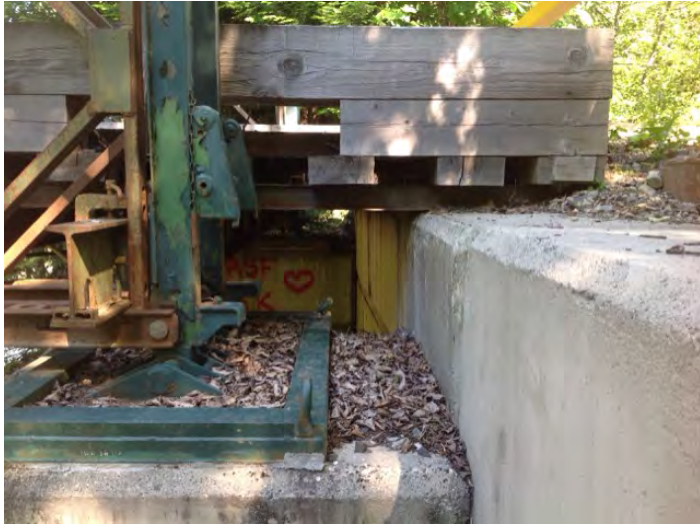
end detail

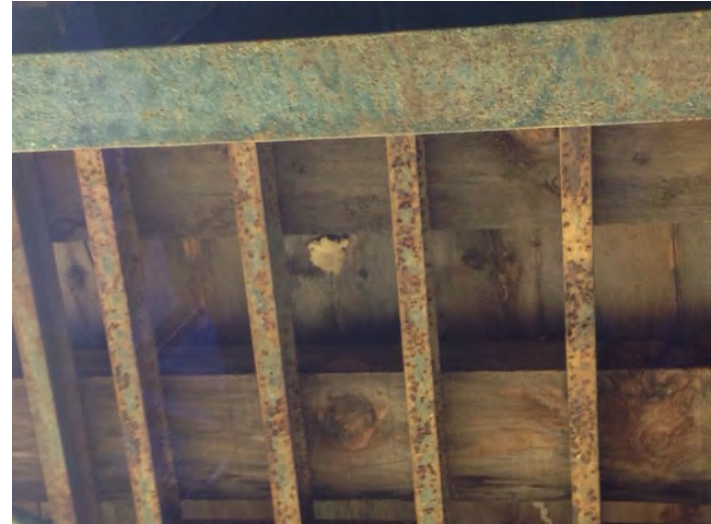
| Running Planks | Fair | rot starting to show underneath |

decking starting to rot

| 1 | deck life | Anually |

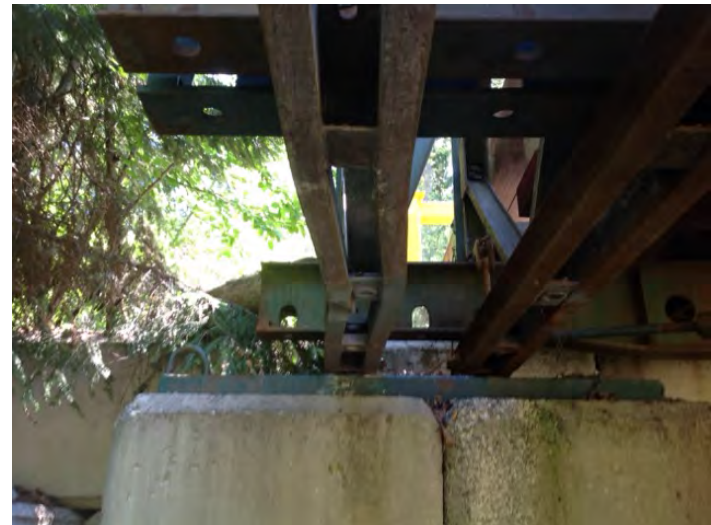
damage to outside panel , right abutment
