CK-2020

CHEHALIS 6km

2015 Inspection

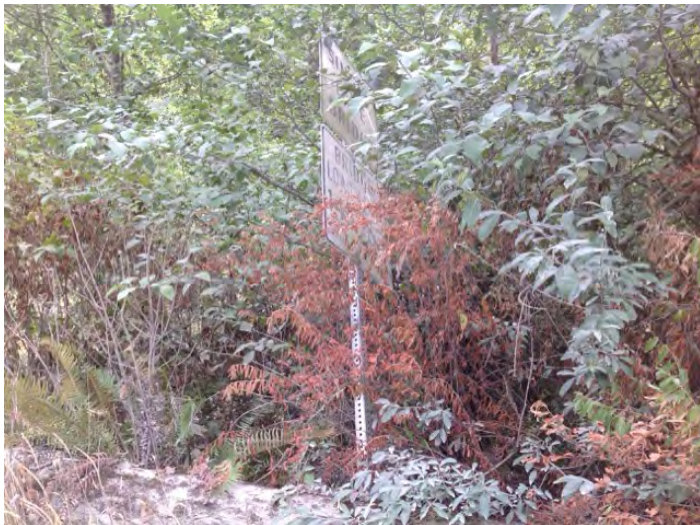
sign pushed over

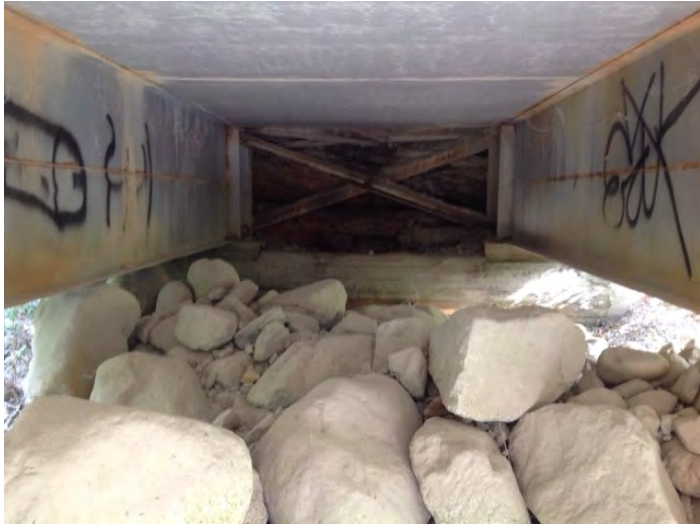
Left Bank Abutment when facing downstream

Riprap Poor none in front of cribs

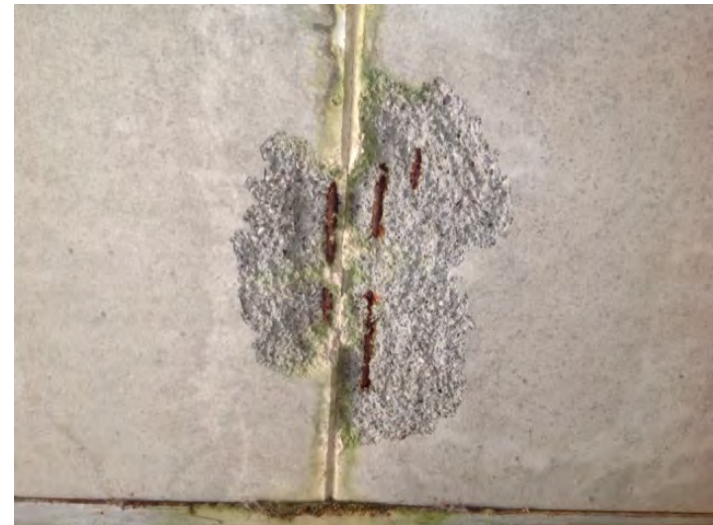
The guardrail, risers and blocks are nearing the end of their useful life - replace soon. Monitor spalling deck panels 1 and 2. Present load rating of L165 or 150 tonnes to continue.

spalling concrete under panel 1 and 2 on right side

| Item | Monitor Description | Frequency |
|---|---|---|
| 1 | spalling concrete under panels 1 and 2 | Routine Inspection |

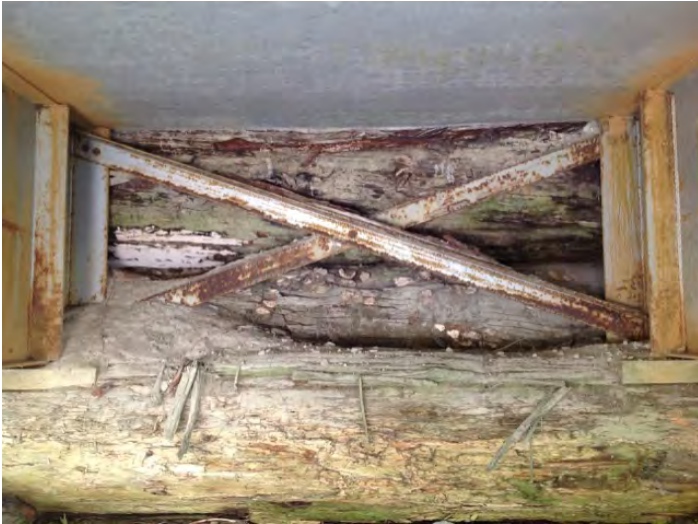
right abutment bracing condition

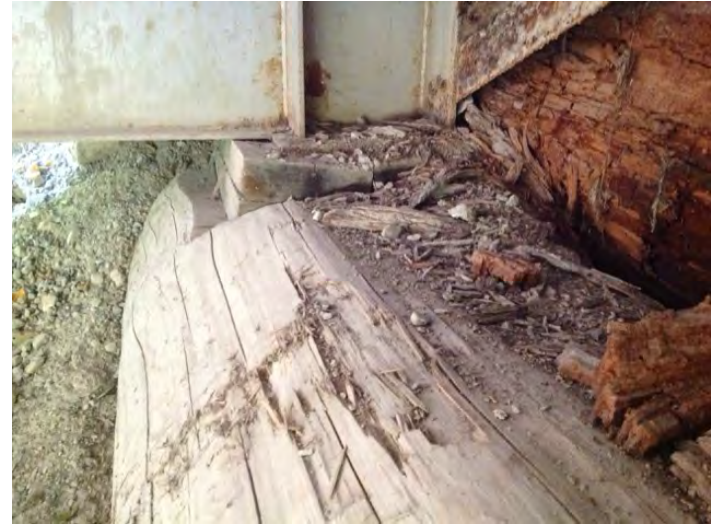
Caps or Sills Fair treated 100mm thick cap shims under girders

left upstream cap shims
