CK-2022

CHEHALIS 15.2km

2015 Inspection

| Crossing Name | Statlu Creek |

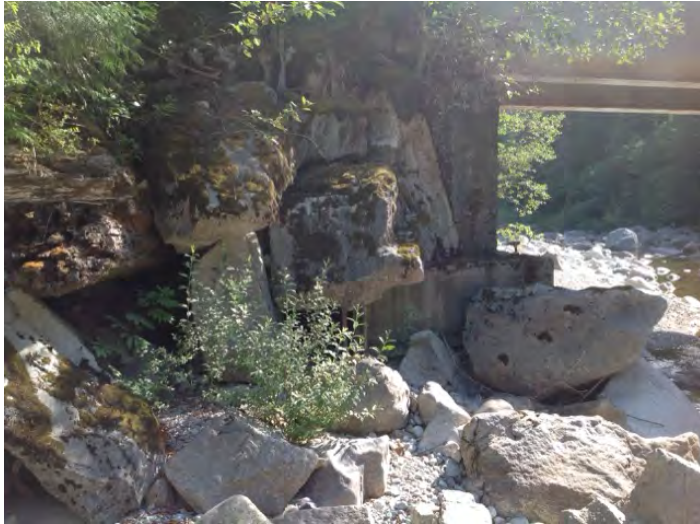
upstream left abutment

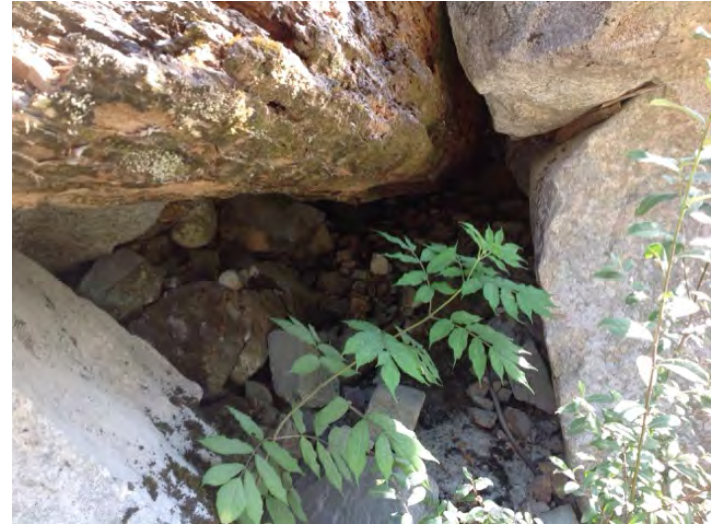
voids in left upstream abutment

Monitor both abutments and tie condition. Present load rating of L100 or 91 tonnes to continue.

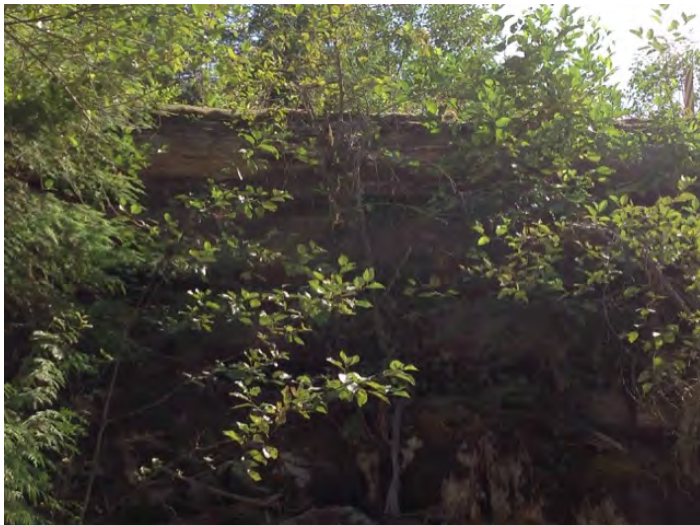
upstream left wing wall

| Item | Monitor Description | Frequency |
|---|---|---|
| 2 | upstream left wing wall condition | Anually |

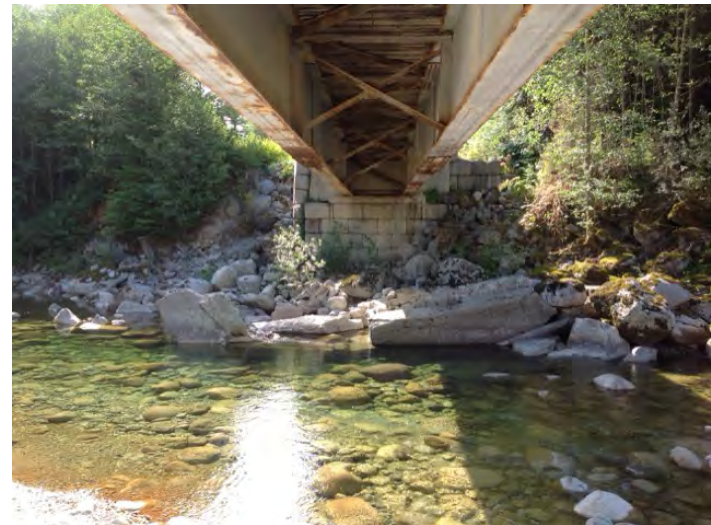
Right Bank Abutment when facing downstream

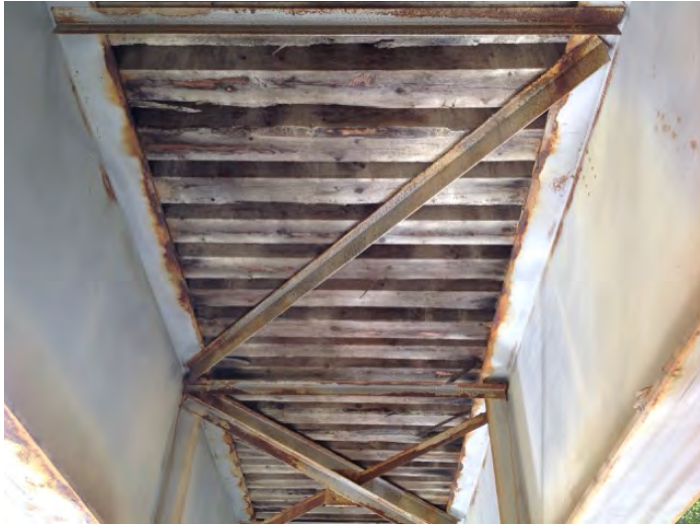
tie condition from underneath

| Item | Monitor Description | Frequency |
|---|---|---|
| 3 | ties and du deck condition | Anually |

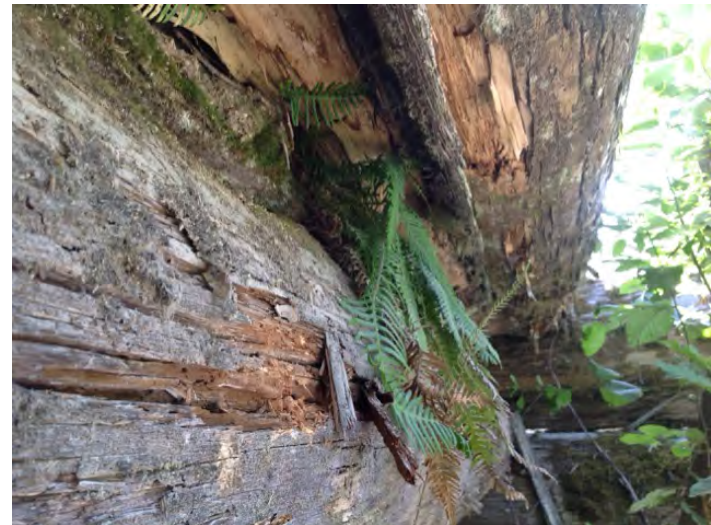
Wing Wall Fair lock blocks right downstream, logs on left

left upstream wing wall log condition - typical

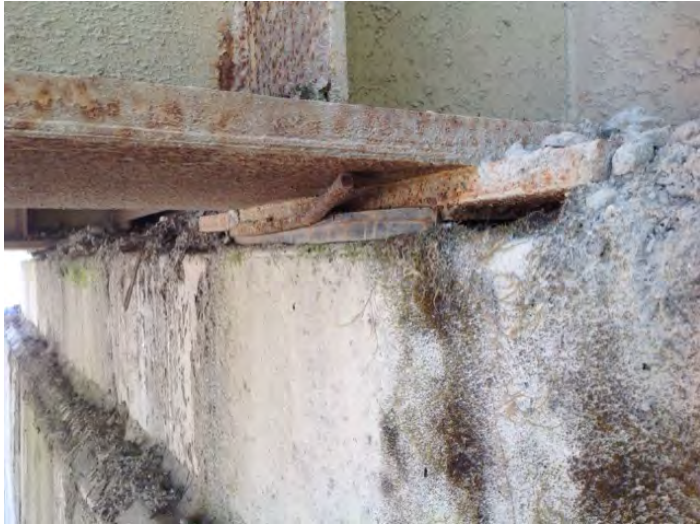
Bearings Fair rubber pads on right starting to buldge

right upstream bearing pad keeper separating

| Item | Monitor Description | Frequency |
|---|---|---|
| 1 | bearing on right abutment<br>left abutment | Anually<br>Anually |

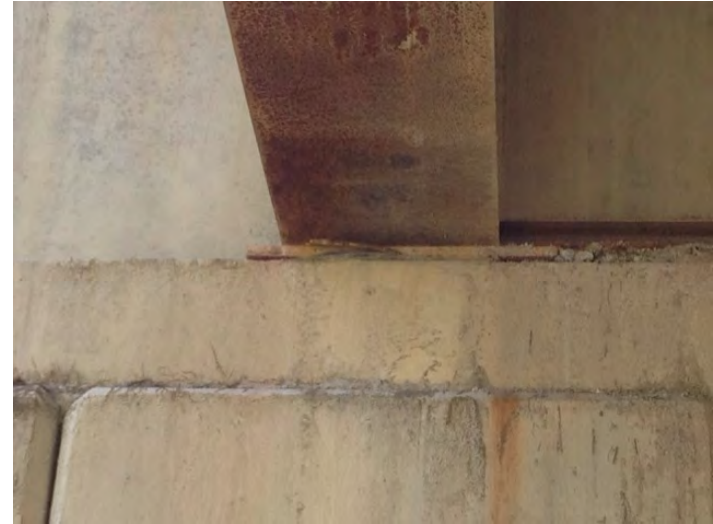
right downstream bearing pad keeper separating

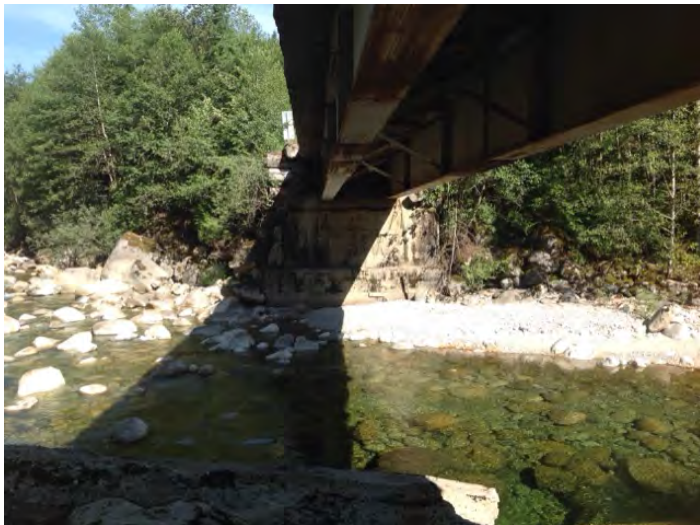
Left Bank Abutment when facing downstream

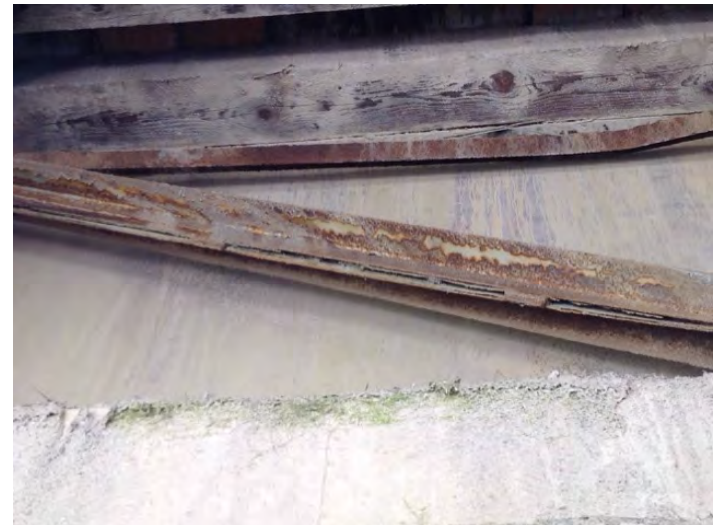
right abutment bracing
