CK-2026

CHEHALIS 27.4km

2015 Inspection

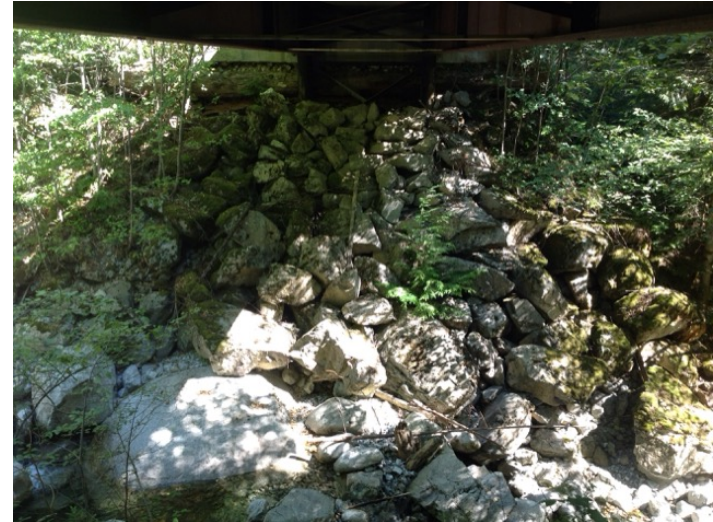
Left Bank Abutment when facing downstream

Hardware Poor loose rail bolts

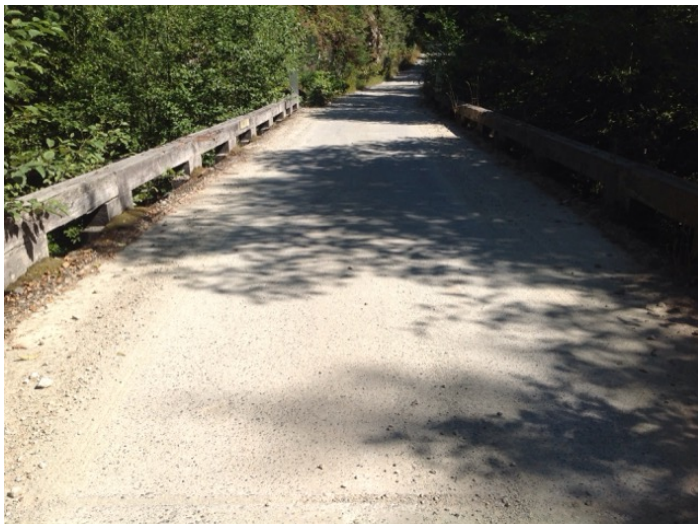
| Curb Rail/Blocks/Posts | Poor | rotten |
| Overall Deck Condition | Poor | due to rail |

| 1 | Medium | replace guardrail, risers and blocks |

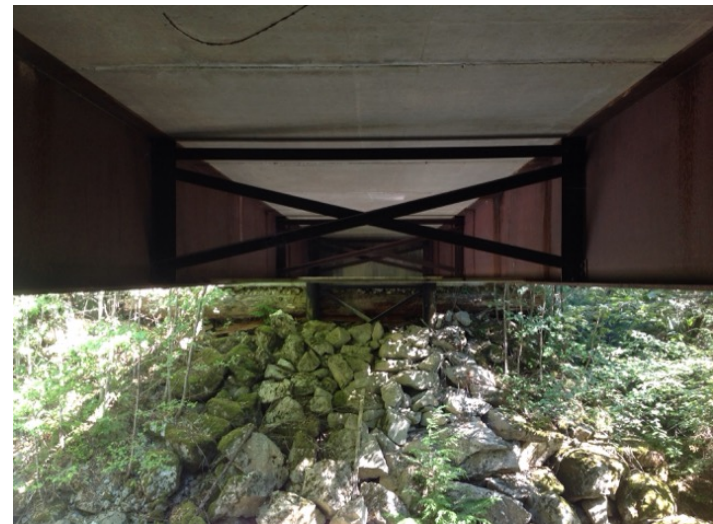
superstructure

Girders Good

Diaphragms Good 4 bays, bolted
