CK-2032

CHEHALIS-STATLU 4.9km

2015 Inspection

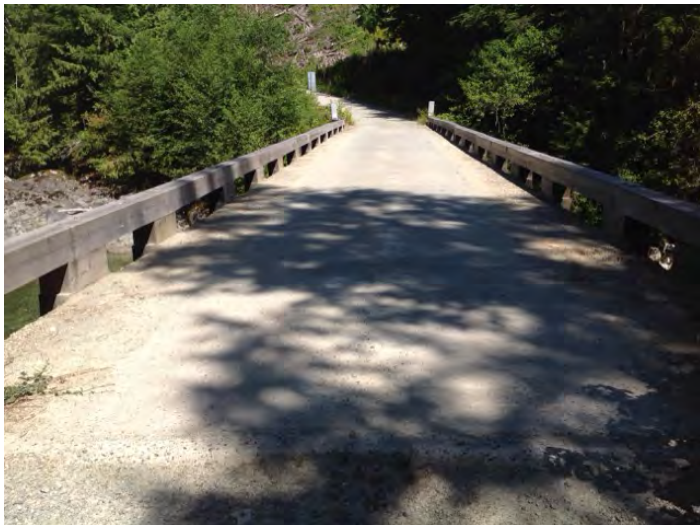
Concrete Deck Fair

Grout Pockets Fair

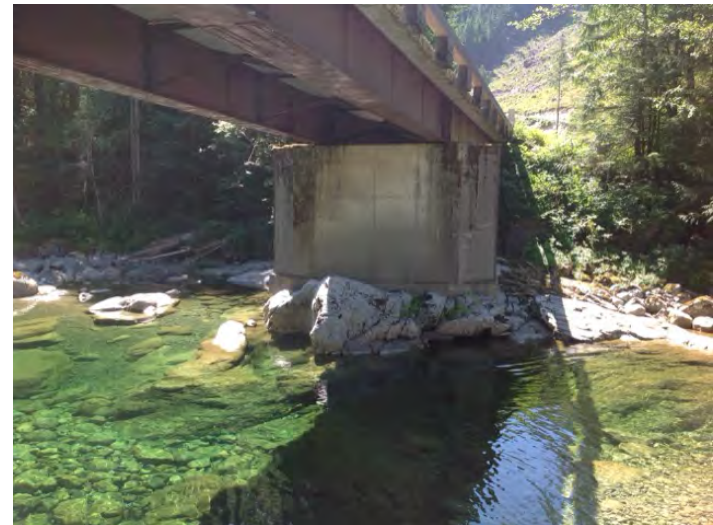
Concrete Good pier and right bank bin wall

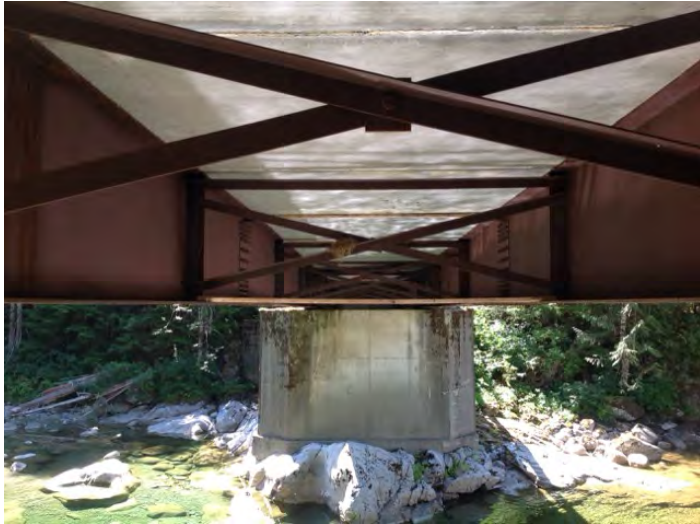
main span superstructure

Diaphragms Good 3 bays on jump span, 6 bays on main span - both bolted

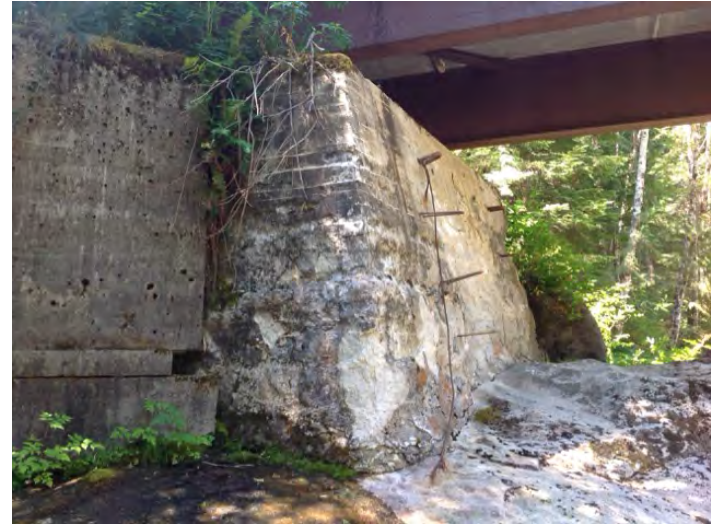
Right Bank Abutment when facing downstream

Bin Wall Fair CIP right bank

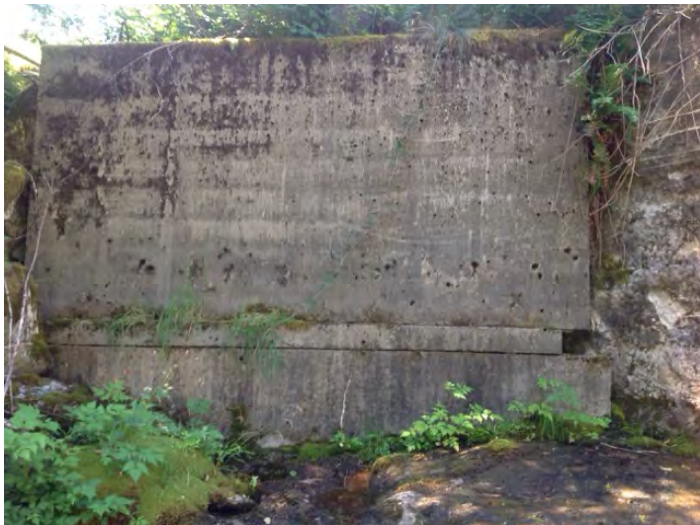
right downstream wing wall

Wing Wall Fair only downstream right approach
