CK-2035

CHEHALIS-SOUTHSTATLU 0.1km

2015 Inspection

Crossing Name Statlu River

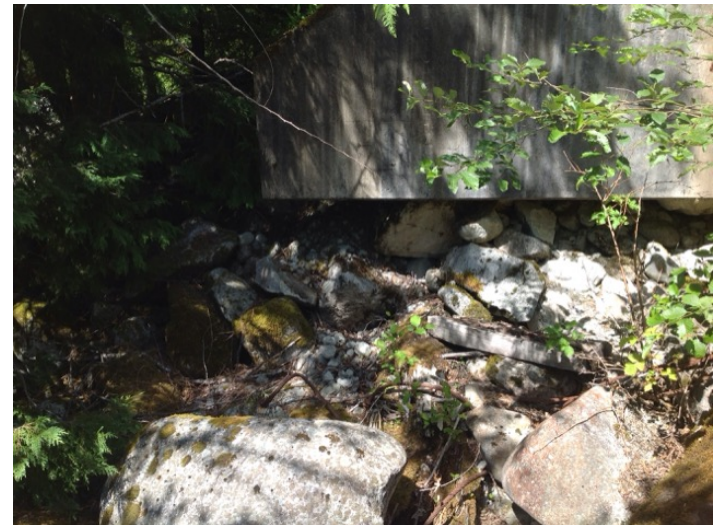
fill erosion from under the downstream right ballast wall
