CK-2036

CHEHALIS-SOUTHSTATLU 0.2km

2015 Inspection

| Crossing Name | Statlu Creek |

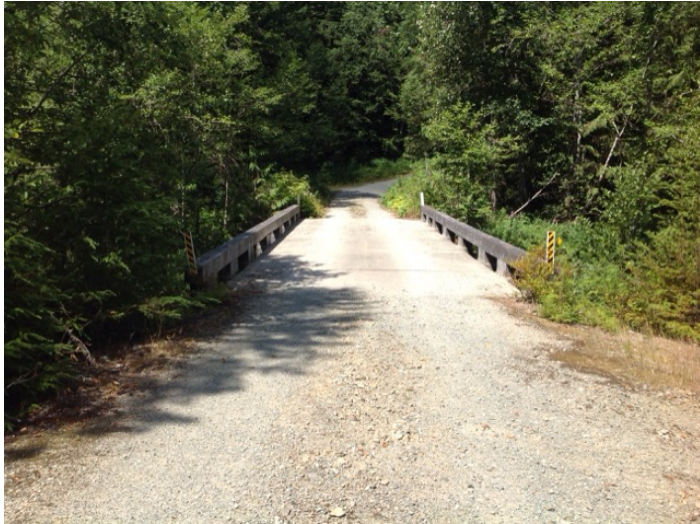
Approach from Left Bank when facing downstream

Brushing Required Y minor

Fender Condition Poor none

Place fenders and brush approaches. Present load rating of L150 or 136 tonnes to continue.

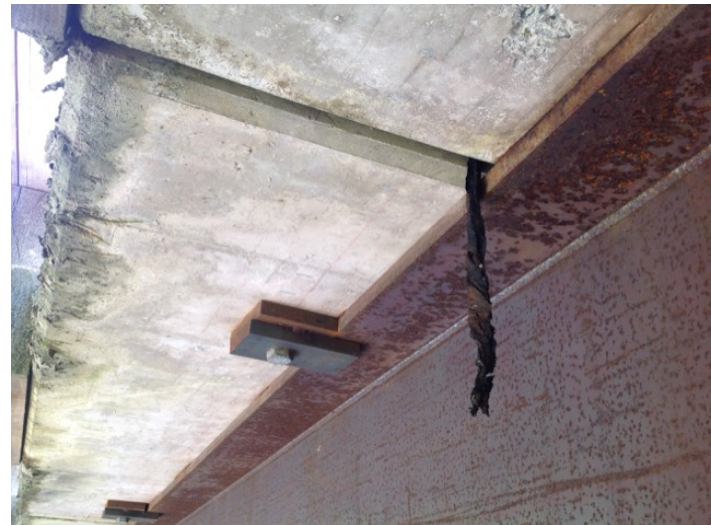
Deck Joints      Fair      no rubber seals

rubber seals rotted out

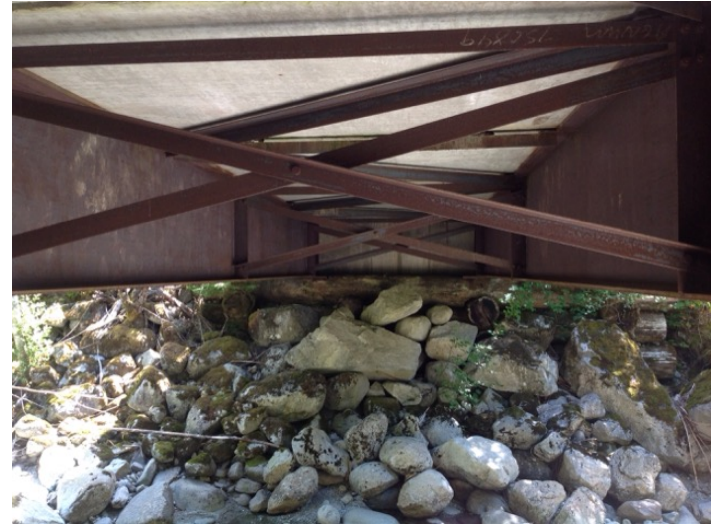
superstructure

Girders Good

Diaphragms Good 4 bays, bolted

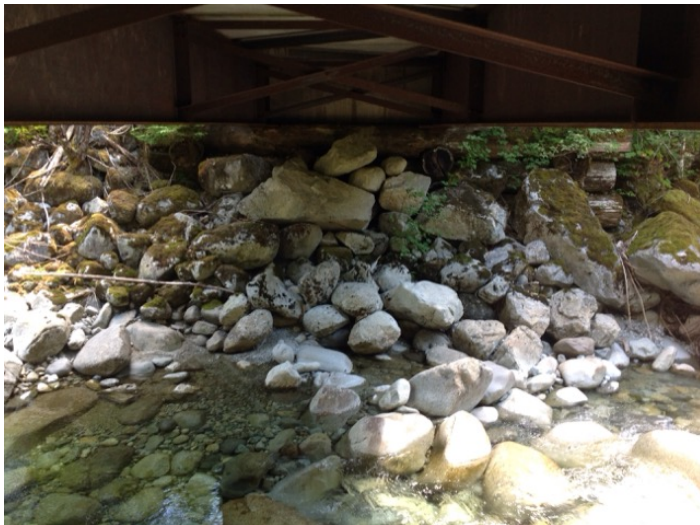
Left Bank Abutment when facing downstream

Log/Timber Cribs Fair 4x left, 3x right
