CK-2037

CHEHALIS-SOUTHSTATLU 3.7km

2015 Inspection

| Crossing Name | Towhead Creek |

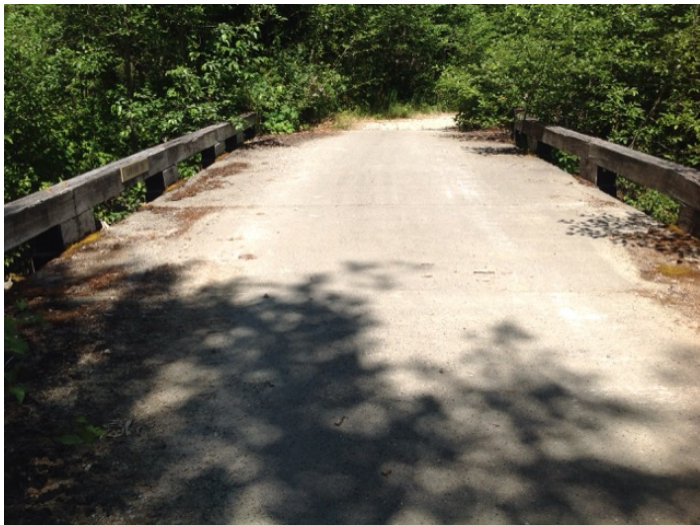
| Curb Rail/Blocks/Posts | Poor | rotting blocks and risers |
| Overall Deck Condition | Poor | due to rail |

| Repair Item | Priority | Repair Description |
|---|---|---|
| 1 | Medium | replace guardrail, risers and blocks once road opened |
