CK-2038

CHEHALIS-SOUTHSTATLU 5.9km

2015 Inspection

| Crossing Name | South Statlu Creek |

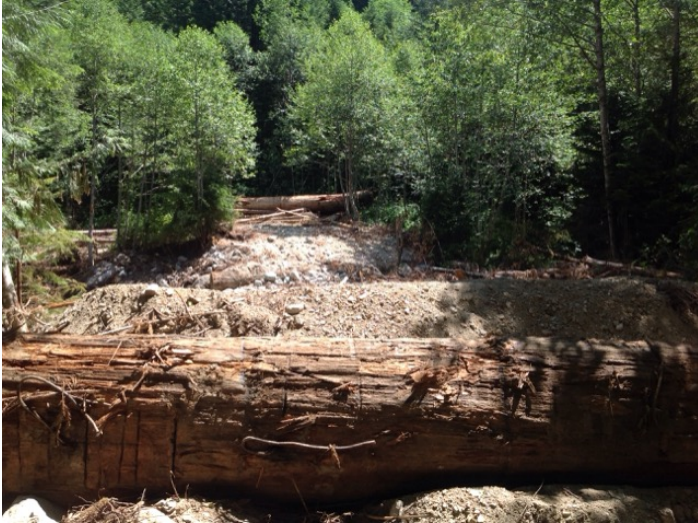
deactivated

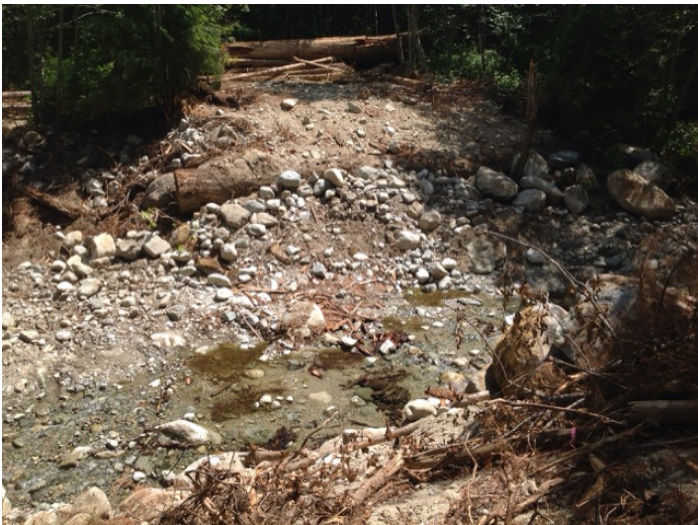
deactivated
