CK-2041

CHEHALIS-FLEETWOOD 3.7km

2015 Inspection

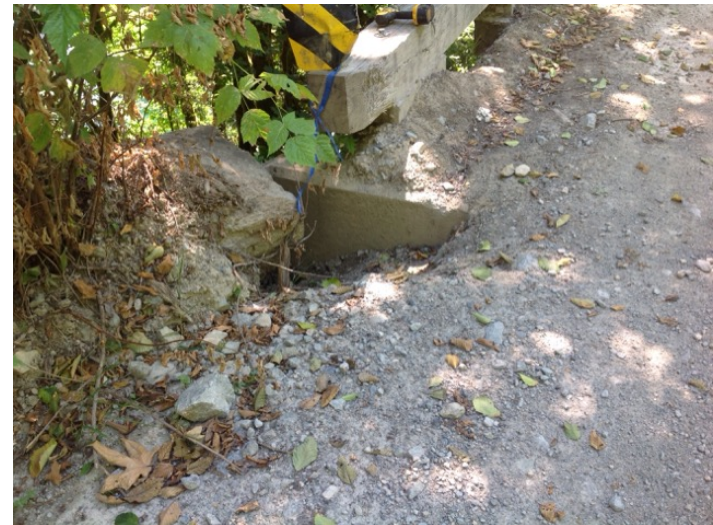
eroding fill left downstream approach

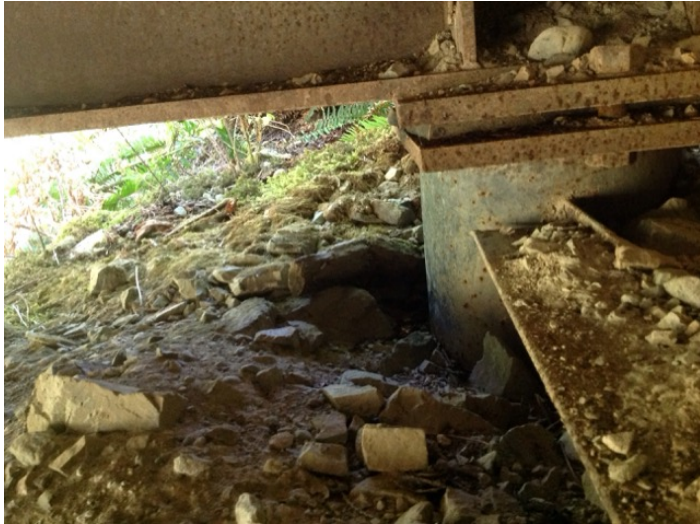
Bearings Fair

bulging pads - off centre plates

Replace missing delineators and brush approaches. Monitor bulging bearing pads. Present load rating of L150 or 136 tonnes to continue.
