CK-2047

CHEHALIS-MYSTERY 11.9km

2015 Inspection

| Crossing Name | Mystery Creek |

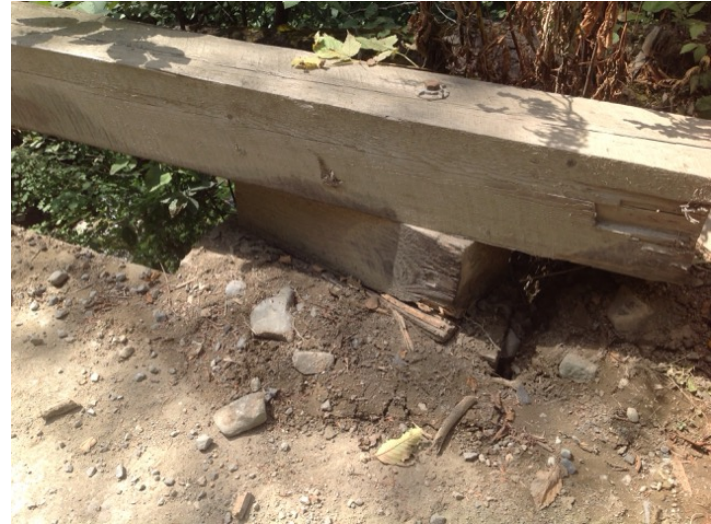
Curb Rail/Blocks/Posts Fair repair section that has shifted off riser

guardrail off riser

Repair section of guardrail that has moved off its riser. Replace missing delineators. Present load rating of L60 or 54 tonnes to continue.

| Repair Item | Priority | Repair Description |
|---|---|---|
| 1 | Medium | repair section of guardrail that has come off riser |

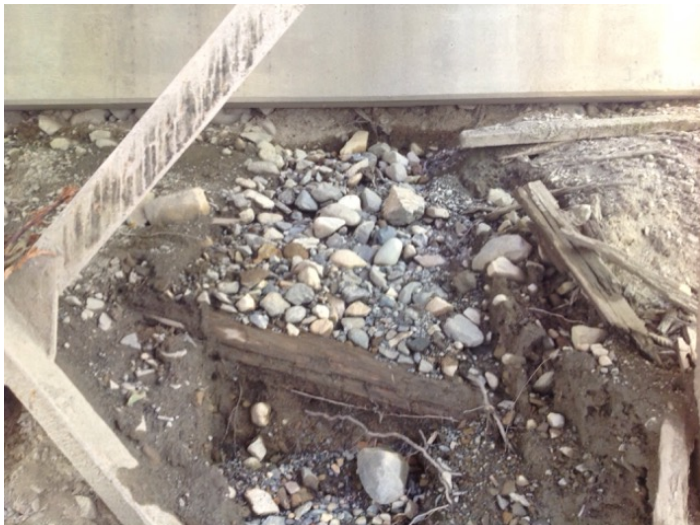
fill ravelling under ballast wall on left bank
