CK-2051

CHILLIWACK RIVER 8.1km

2015 Inspection

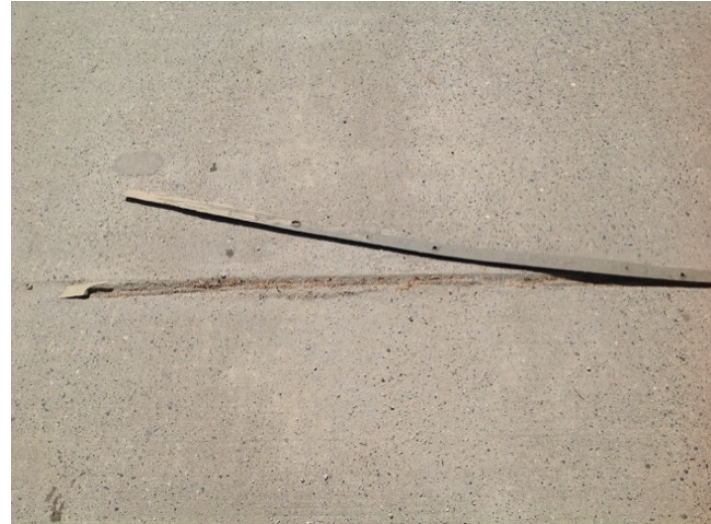
Deck Joints      Fair      some sealant popping out and requires replacement

sealant worn and failing

Replace deck sealant, replace missing bridge ahead signs and brush with activity. Present load rating of CL-625 or 68 tonnes to continue.

| 2 | Medium | replace all deck sealant prior to industrial activity |

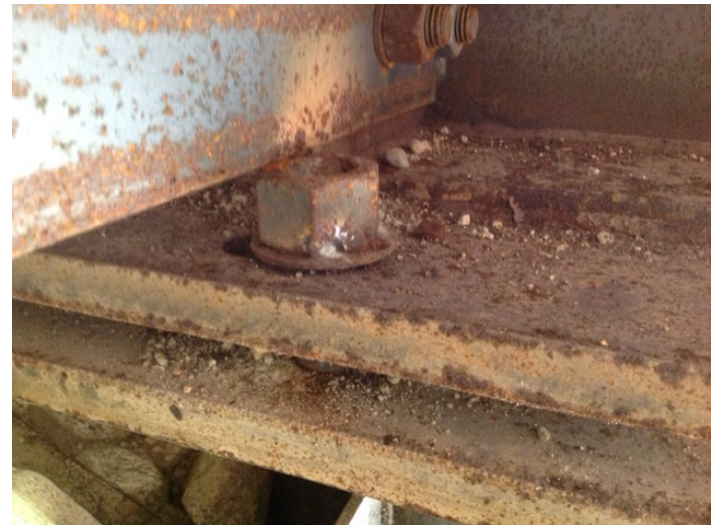
bearing plates at extent of slot

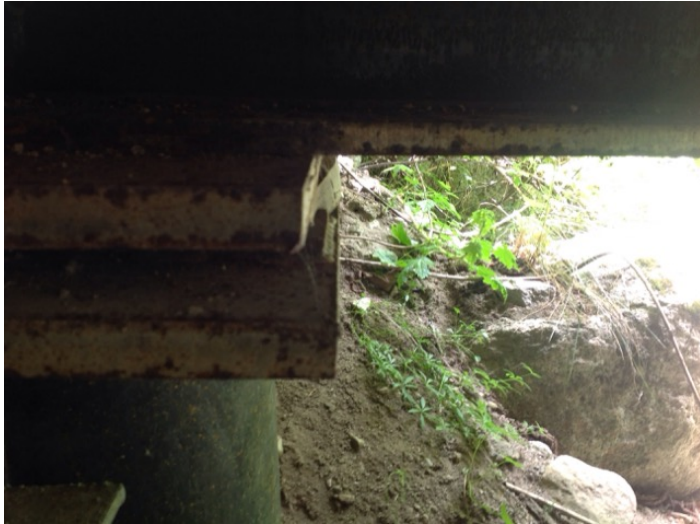
bearing plates offset 14mm
