CK-2072

BENCH 5.2km

2015 Inspection

| Crossing Name | Wells Ranch Creek |

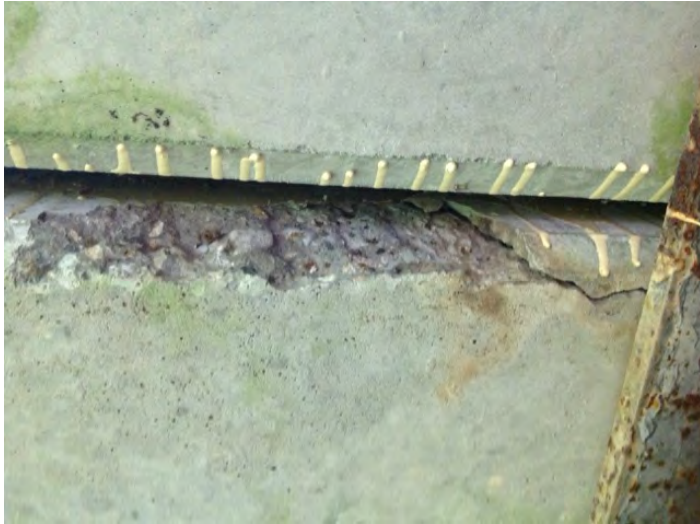
| Concrete Deck | Fair | panel 1 on left approach has damage on ballast wall side where rebar is exposed and rusting - same for right approach |

small panel damage

| 2 | Medium | repair damaged deck panels |

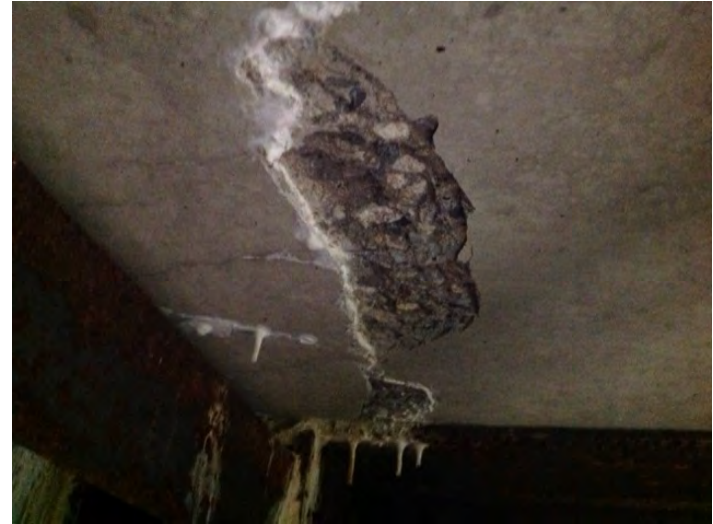
spalling concrete

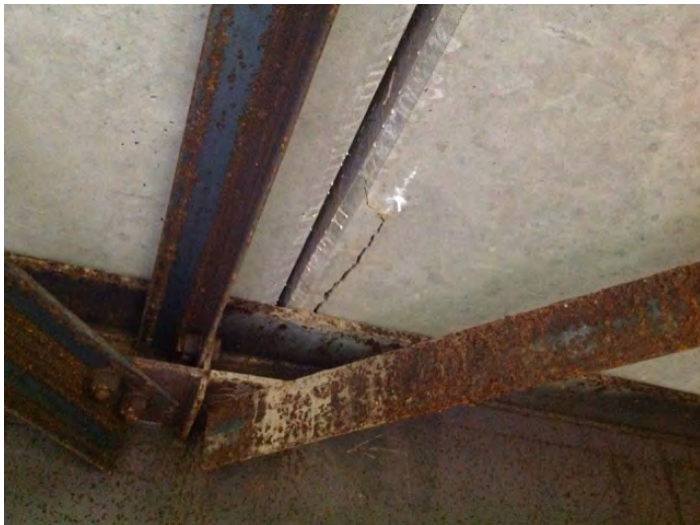
small panel damage

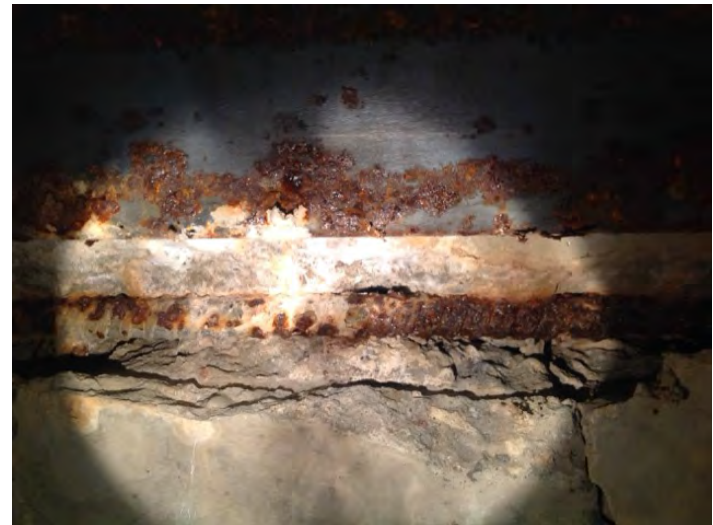
left abutment panel damage

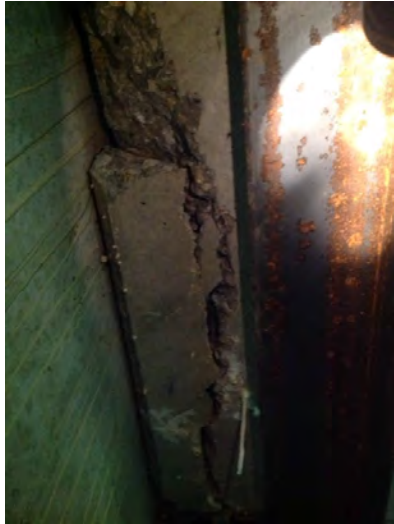
| 1 | panel 1 on both approaches - exposed rebar | Routine Inspection |

panel 1 on right bank damage
