CK-2078

CENTRE CREEK 2.3km

2015 Inspection

| Crossing Name | Centre Creek |

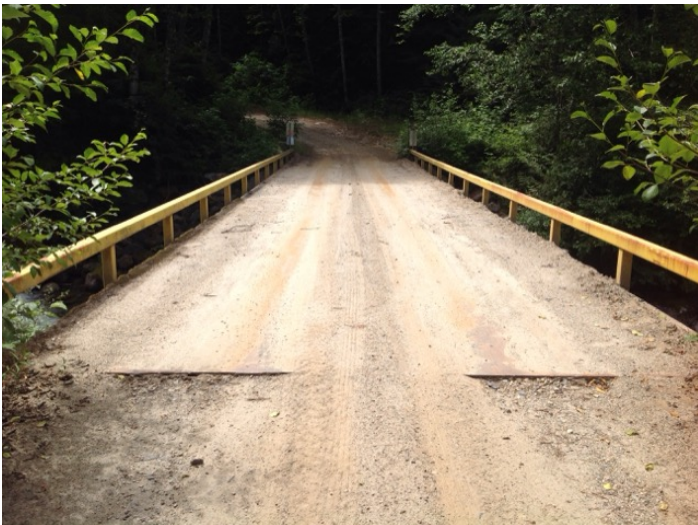
| Steel Deck Plate | Fair | anti skid worn on wheel path |
