CK-2086

CHILLIWACK SOUTH 4.4km

2015 Inspection

| Crossing Name | Center Creek |

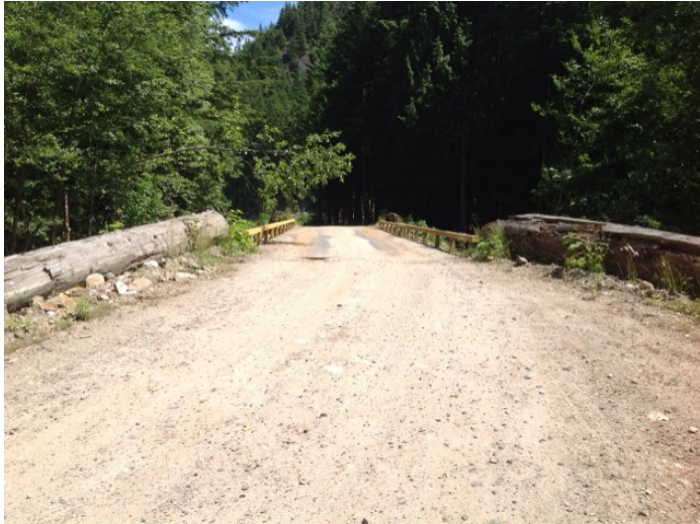
Approach from Left Bank when facing downstream

HC and VC left approach

Delineator Missing  
Left ☐ 0 ☐ 1 ☒ 2Delineator Missing  
Right ☐ 0 ☐ 1 ☒ 2

| 1 | Medium | replace missing delineators |

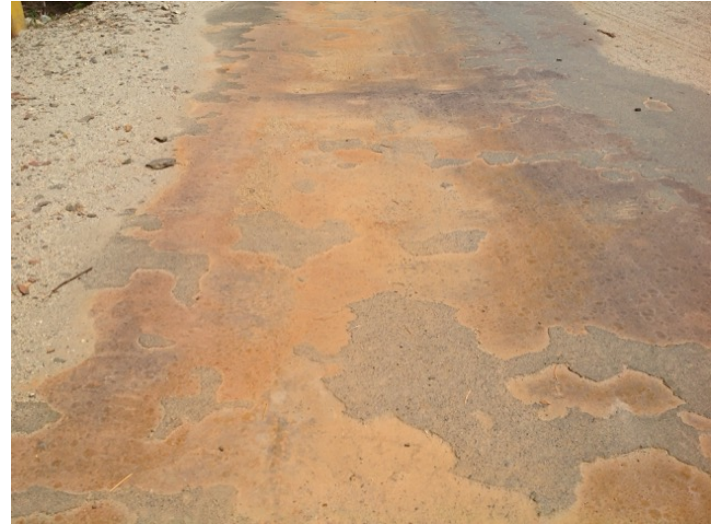
Steel Deck Plate Fair anti skid worn and slight deformation on wheel path

Girders Fair ASP with slight deck deformation

slight deck deformation on running path

| 1 | deck deformation | Routine Inspection |

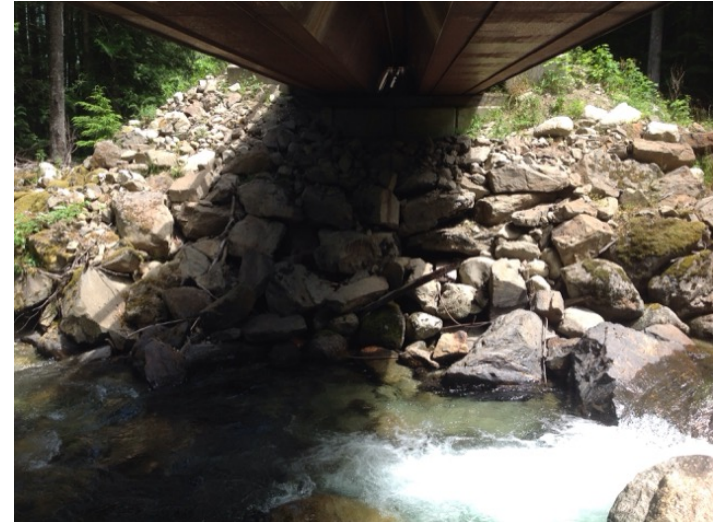
Right Bank Abutment when facing downstream

Concrete Good lock blocks visible right
