CK-2087

DEWDNEY CREEK 5.2km

2015 Inspection

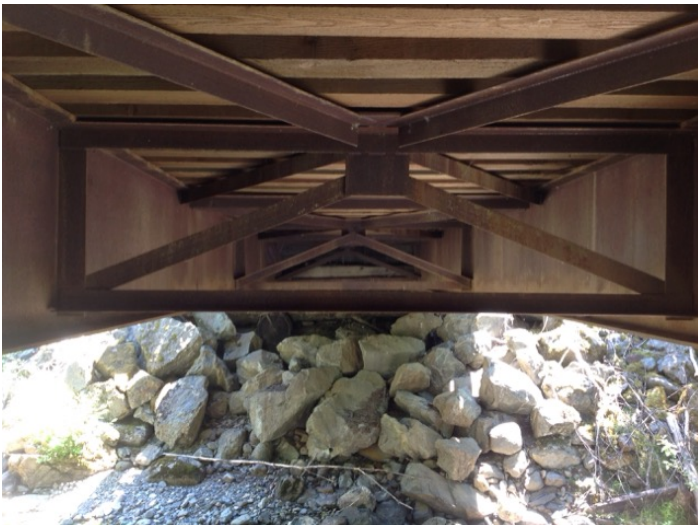
superstructure

Girders Fair minor corrosion
