CK-2090

DEWDNEY SIX 0km

2015 Inspection

| Crossing Name | Coquihalla River |

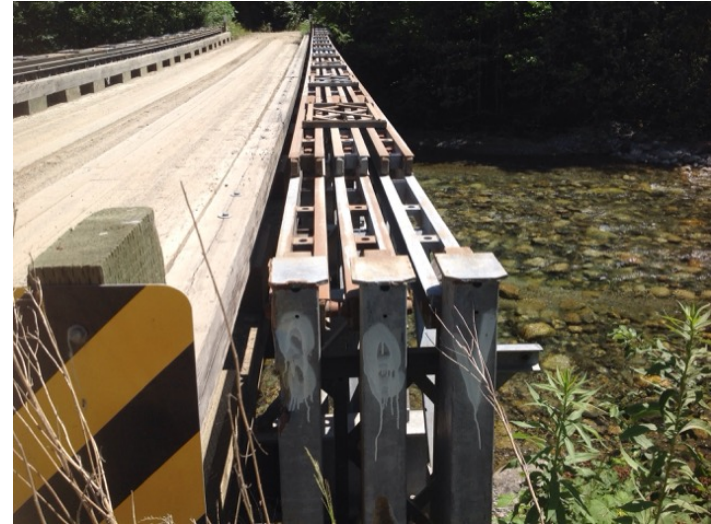
triple single reinforced Acrow

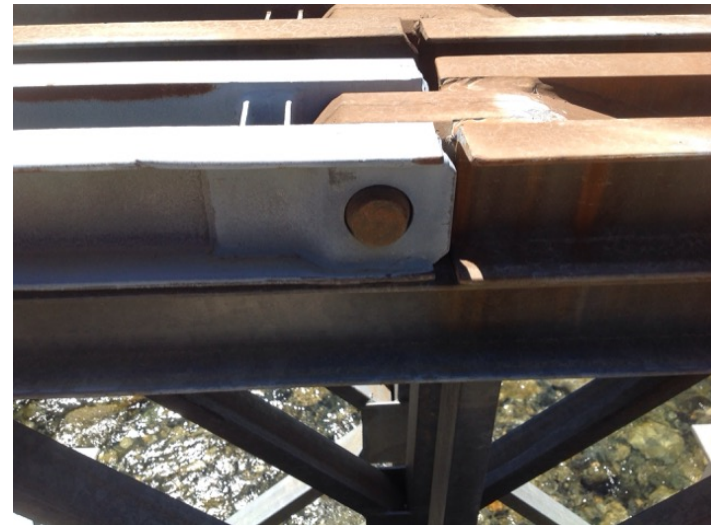
Hardware Fair few loose pins with missing circlips

odd pin without circlip

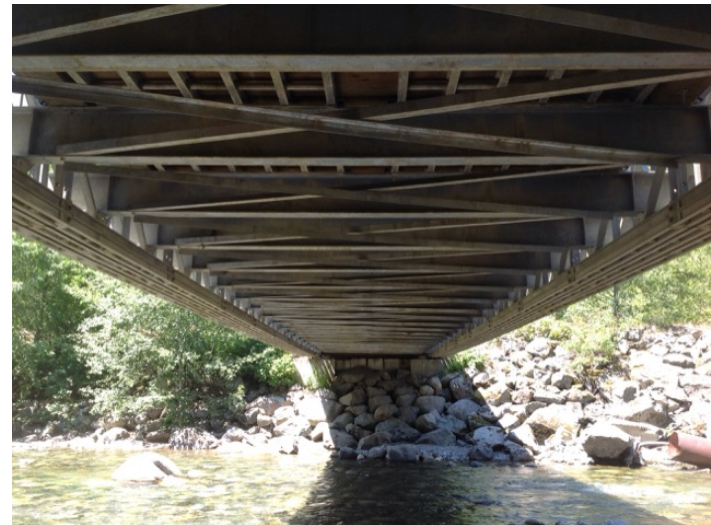
Comments    estimated 100-150mm sag in superstructure

Monitor sag. Present load rating of L60 or 54 tonnes to continue.
