CK-2091

FLORENCE LAKE 2.8km

2015 Inspection

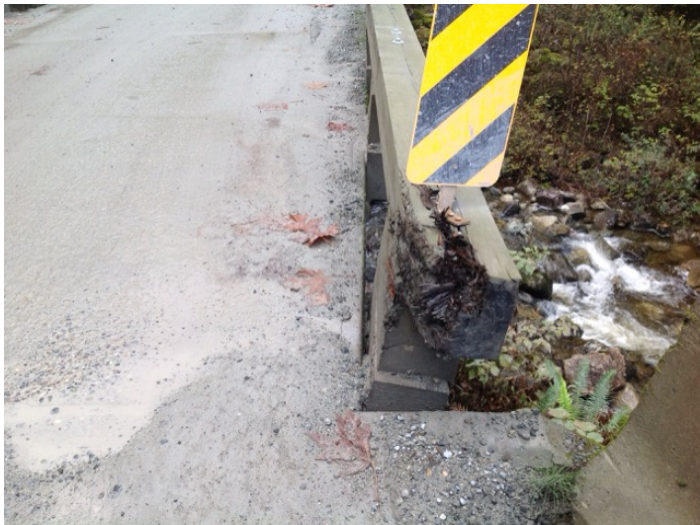
Curb Rail/Blocks/Posts Fair damage on right downstream approach

Guard Rail damage

Repair damaged section of guardrail. Present load rating of L75 or 68 tonnes to continue.

| Repair Item | Priority | Repair Description |
|---|---|---|
| 1 | Medium | repair downstream right approach guardrail |

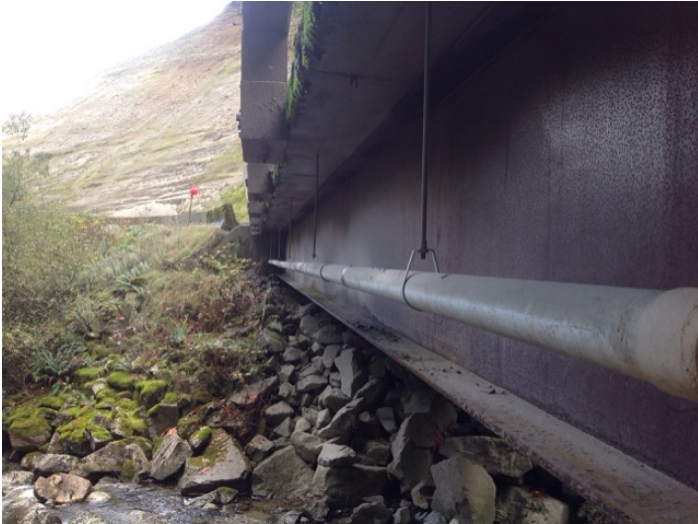
fibre optics line hung from deck panels

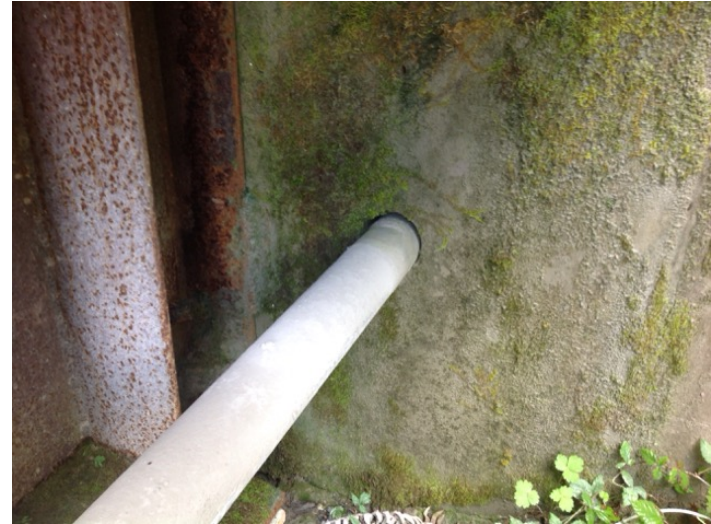
fibre optics line access through ballast wall
