CK-2093

FLORENCE LAKE 7km

2015 Inspection

Crossing Name 79 Creek

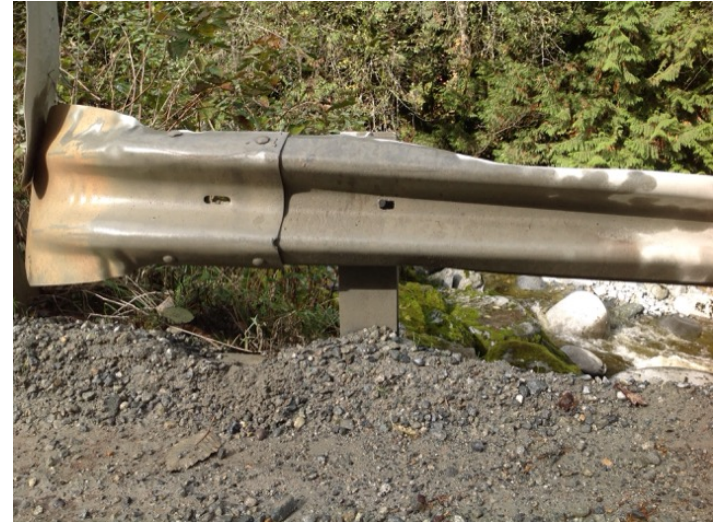
guardrail not bolted to post upstream right approach

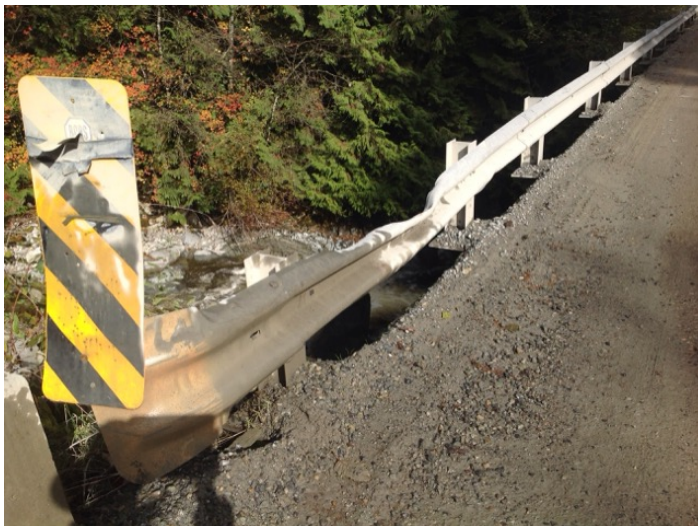
guardrail damage

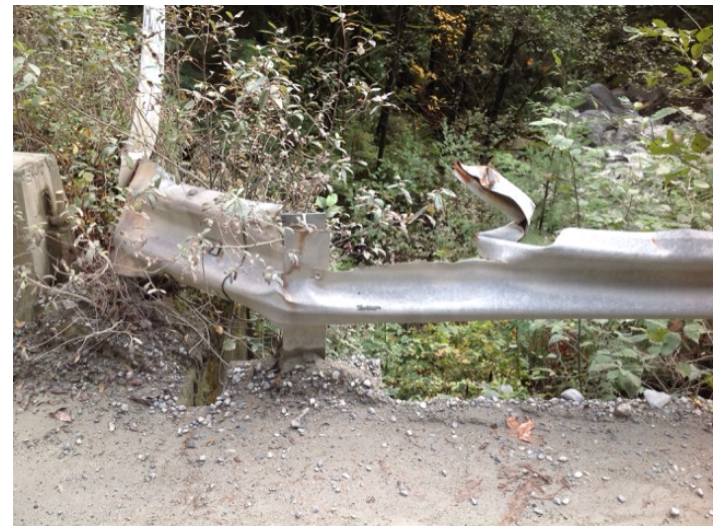
guardrail damage left downstream approach

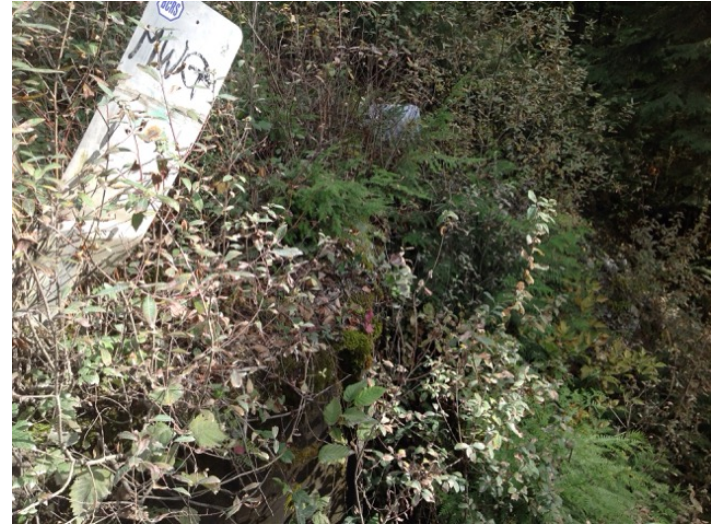
left downstream wing wall

Wing Wall Good only downstream left

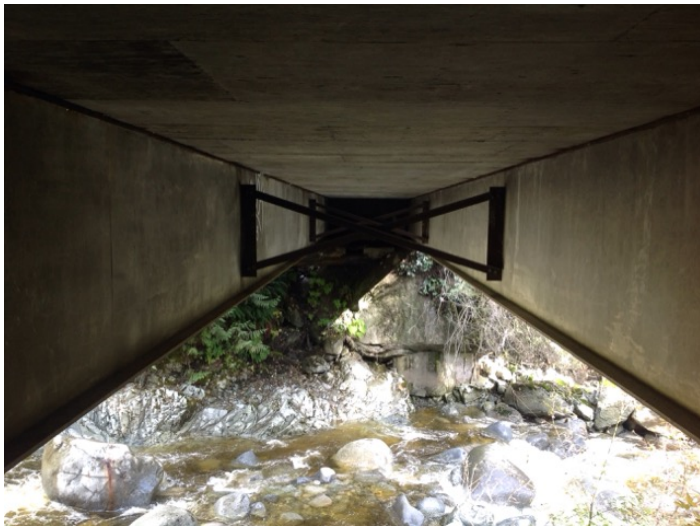
superstructure

Girders Fair composite girders with hairline cracks
